UMTRI-85-20

MEASUREMENT OF CRASH AVOIDANCE  
CHARACTERISTICS OF VEHICLES IN USE

Paul L. Olson  
Christopher B. Winkler

FINAL REPORT  
October 1985

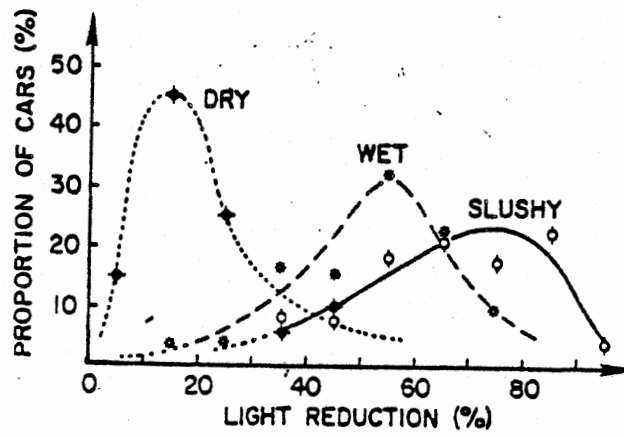
Figure 20. Proportion of cars at gas stations having various degrees of light reduction in the central part of the high beam caused by dirt under three road conditions.

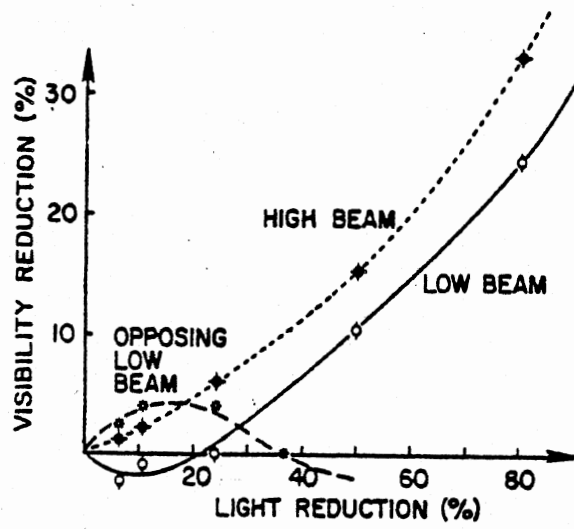
Figure 21. Visibility reduction caused by light attenuation due to dirt for three conditions obtained in controlled experiments.

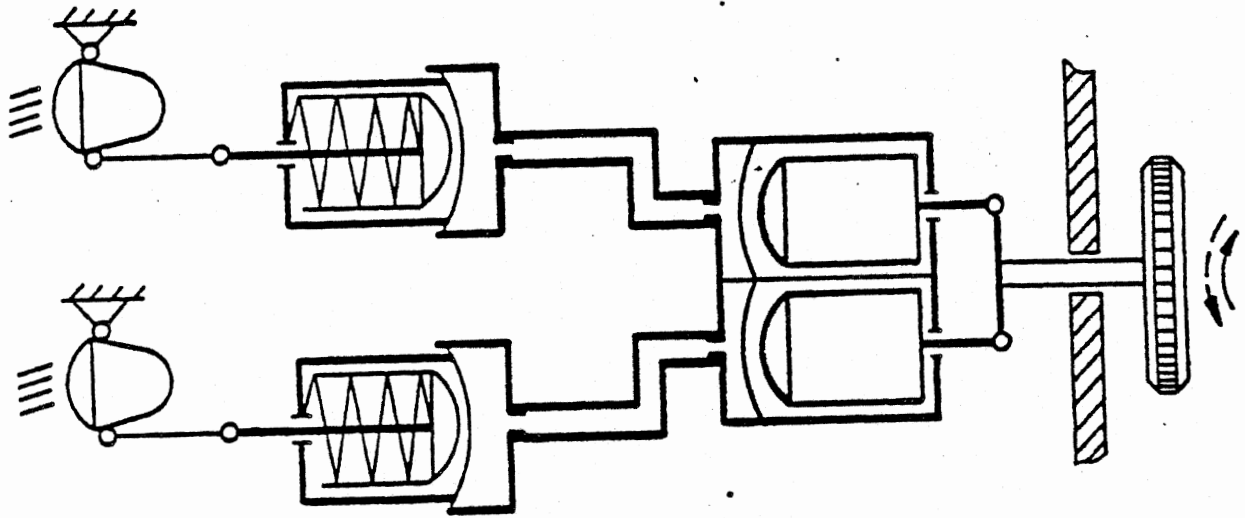
Figure 23. Schematic of manual hydraulic headlamp leveling system.

Three types of manual control systems are diagrammed in Figures 23 through 25 (Hella, 1983). The first of these (Figure 23) is hydraulic. Turning the knob clockwise in

the driver's compartment causes fluid to be displaced within the control cylinder, pushing out the pistons located at each headlamp, and raising the aim of the beam. Rotating the knob in the opposite direction reverses the process and the aim is depressed.
