## Right bundle branch block during transvenous ventricular pacing

William S. Abernathy, M.D.

Barry J. Crevey, M.D.

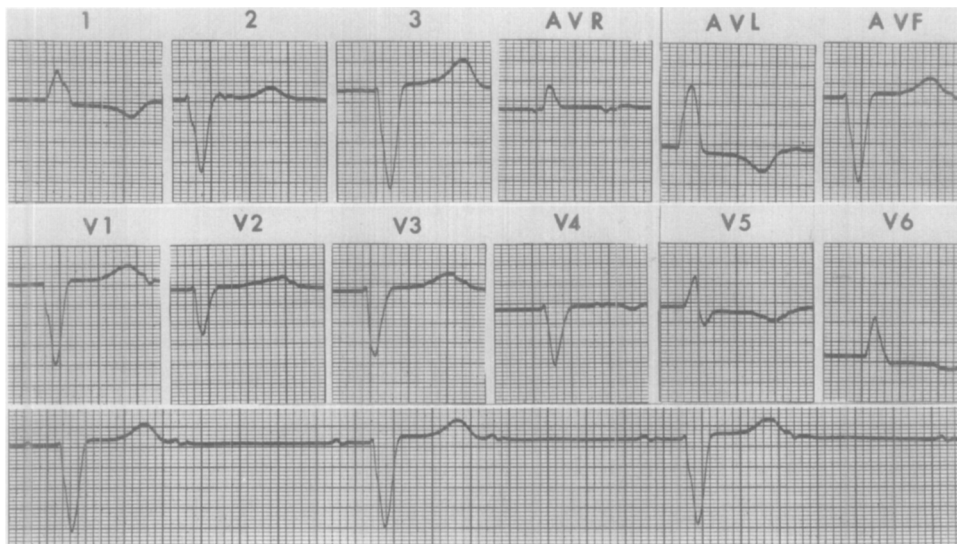
Fig. 1. Electrocardiogram and rhythm strip recorded at 50 mm. per second. All leads are full standard (1 mv. = 10 mm.) except Leads V<sub>1</sub> and V<sub>4</sub> which are one-half standard. See Text.

The initial electrocardiogram (Fig. 1) showed sinus rhythm, complete atrioventricular block, and an idioventricular rhythm. Pacing through a transvenous bipolar electrode catheter produced RBBB. An electrogram recorded from the distal electrode demonstrated a dominant S-wave characteristic of recordings from the apex of the right ventricle (Fig. 2).<sup>1</sup> For the seven days this catheter was in place the stimulating threshold was always less than 1.0 ma. No pericardial rub was heard, and no complications developed.

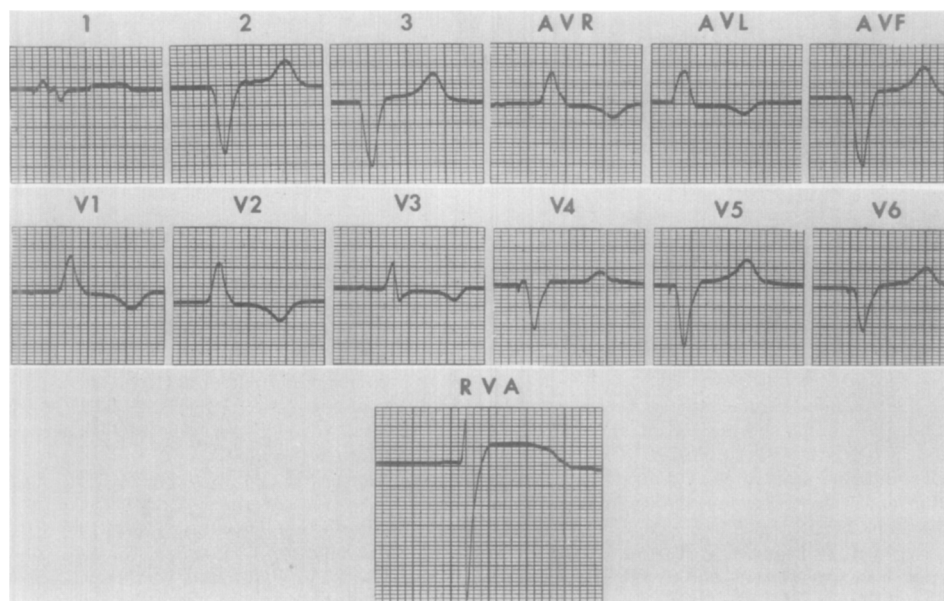
Fig. 2. Electrocardiogram and electrogram recorded from the apex of the right ventricle (RVA) at 50 mm. per second. All leads are one-half standard (1 mv. = 5 mm.) except Lead I which is full standard and Lead RVA which is one-fifth standard. See text.

In the case reported here, pacing through the temporary catheter produced the classic RBBB pattern (Fig. 2), while pacing through the permanent catheter produced the atypical RBBB configuration (not shown). This case is noteworthy because stimulation from two sites within the

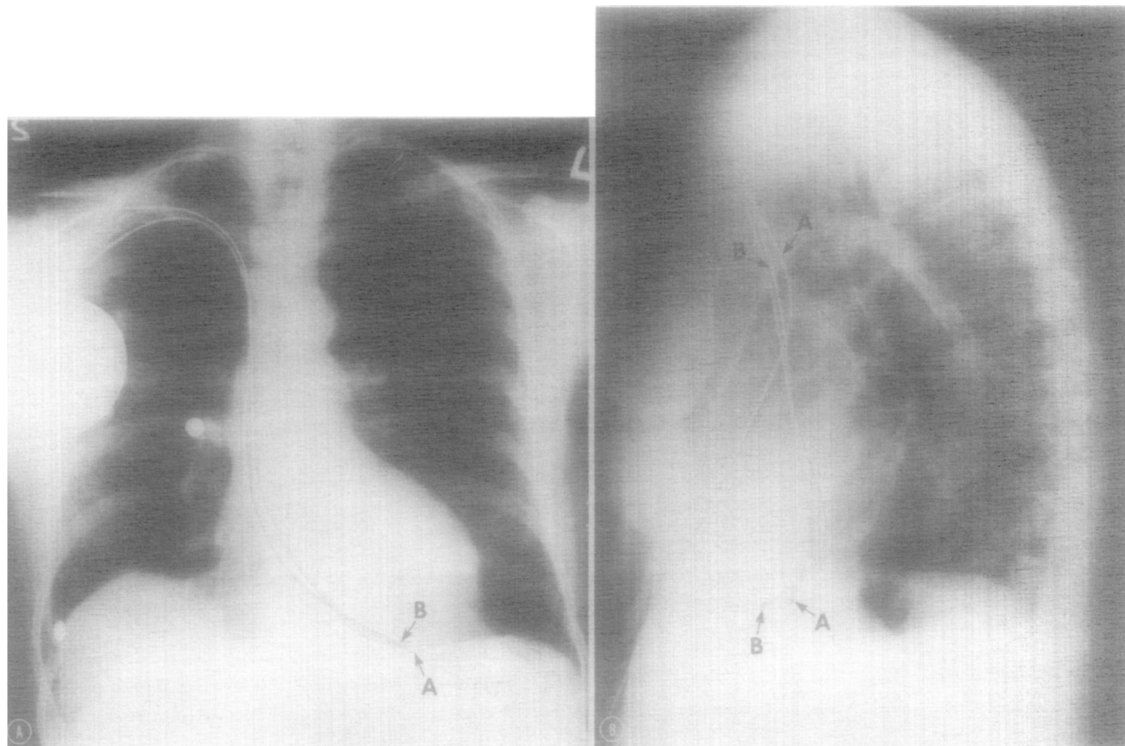
**Fig. 3.** Frontal and lateral roentgenograms of the chest showing the temporary (A) and permanent (B) pacing catheters (retouched for clarity). See text.

Fig. 3 shows the position of the catheters.

That these catheters were in the right ventricle is demonstrated by their position on the roentgenograms, by the appearance of the electrogram, by the constant and low stimulating threshold, by the constantly normal pacing and sensing functions, and by the absence of complications. Any one of these factors alone is inadequate to insure the site of the catheter tip,<sup>1</sup> but taken together they argue strongly for the right ventricular location of the tip.
