ENGINEERING RESEARCH INSTITUTE THE UNIVERSITY OF MICHIGAN ANN ARBOR

Quarterly Report

ATMOSPHERIC PHENOMENA AT HIGH ALTITUDES (August 1, 1956 to October 31, 1956)

Project 2387

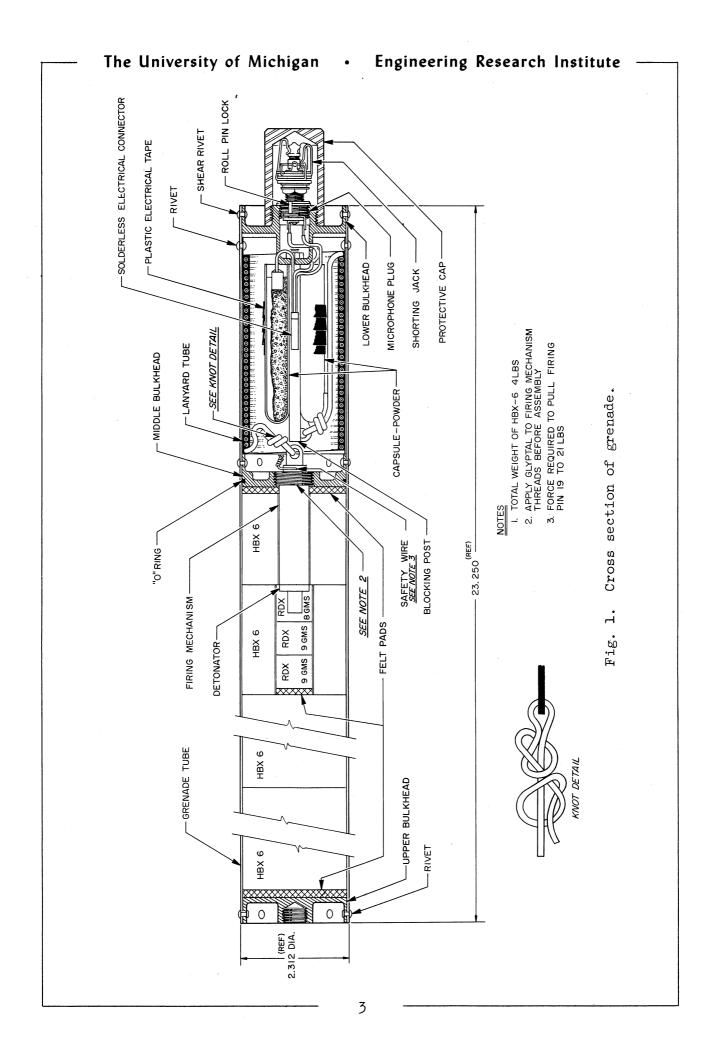
A look at the cross-sectional drawing of the grenade, Fig. 1, will indicate how these design objectives were approached.

The case of the grenade is 23.25 inches long and consists of light-wall aluminum tubing. The explosive occupies approximately 18 inches of the case, with the remainder being utilized for the ejection combustion chamber and lanyard storage.

The firing mechanism consists of a firing pin and cocked spring, encased in a threaded container, and retained by a pull pin. The firing mechanism was originally designed by a commercial company for a time-delay mechanism to be used in another rocket and was adapted to the grenade with some modification. The original design had no specific pull-force requirements for the pin and was dependent on the friction of an "O" ring seated in a groove on the pin to provide an adequate minimum pull-out force. The "O" ring friction system did not provide a consistent and predictable pull force.

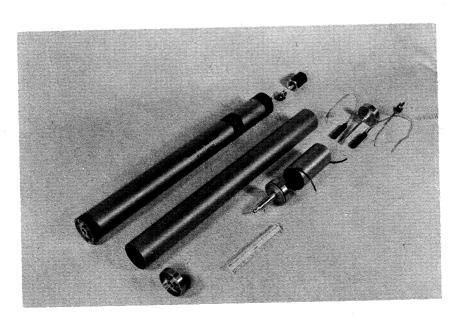
Fig. 2. Assembled grenade and components.

Figures 2 through 7 are photographs of the grenades and of some of the grenade equipment used in the developmental tests.

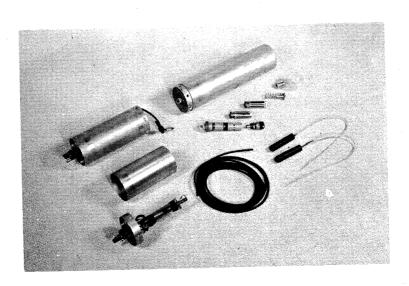
Fig. 3. Components of dynamically similar dummy grenade used for development testing.

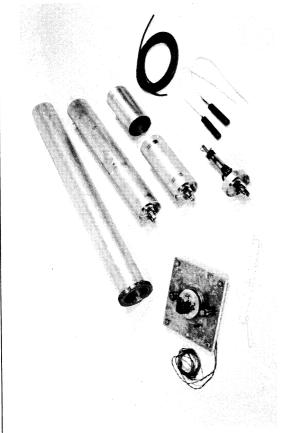
Fig. 4. Equipment used for simulated high-altitude testing of ejection capsules.

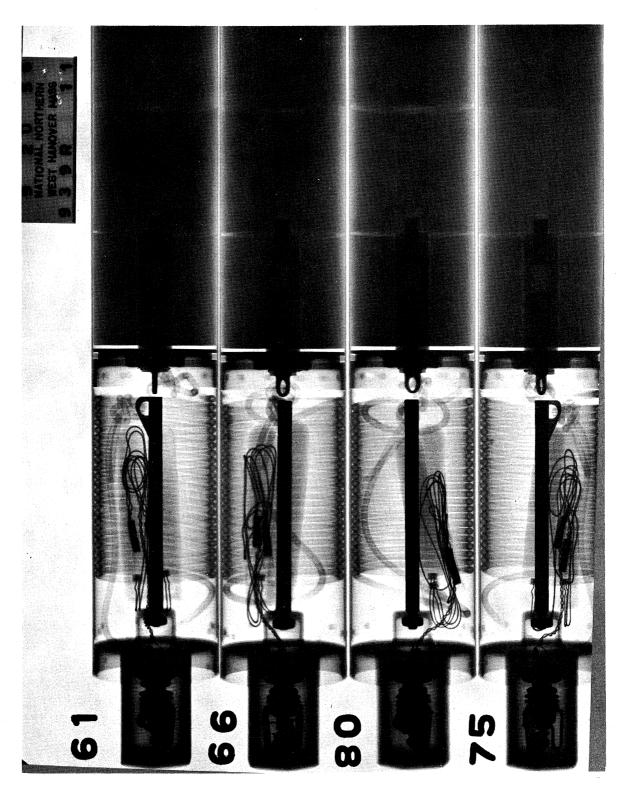
Fig. 7. X-ray inspection photograph of production grenades. Grenades are loaded and ready for firing.

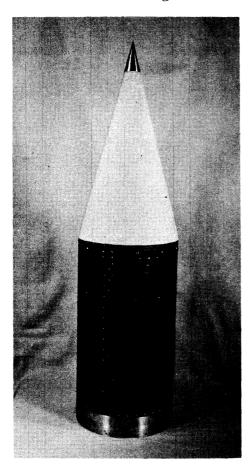
Fig. 8. Finished nose cone installed on grenade section. Frangible covering is punctured by grenades on launching.

The design of the nose cone involved resolving some conflicting requirements into an acceptable compromise. The multiple intersections of mortar tubes and nose surface made it desirable to use a right circular cone as blunt as practical. The aerodynamic requirements called for a long, slender, preferably ogive, nose. The design was finalized as a 30° (included angle) right circular cone (Fig. 8). This nose angle compared favorably with the angle of the standard Aerobee ogive nose.

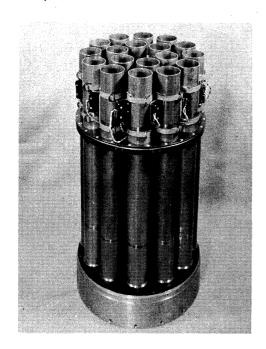
Fig. 9. Grenade section of rocket with skin removed. The high density of grenade packaging possible with this configuration is evident in this view. Microswitches visible on mortar barrels are grenade-ejection indicators.

cone. The grenades are stored in a cluster of 18 closely-spaced mortar tubes axially parallel to the rocket centerline (Fig. 9). Each grenade is fired from its own mortar, eliminating the need for moving parts.

A microswitch is mounted near the muzzle end of each mortar to sense the ejection of the grenade. The normally "on" switch is held in the "off" position while the grenade is in the mortar and returns to the "on" position after the grenade travels approximately 18 inches. The blast from the ejection charge may tend to delay the closing of the switch momentarily, but such delay would be of negligible importance. Tests under actual firing conditions gave highly satisfactory results.

shorting plug, and the ejection-monitor microswitches. These features are shown in Figs. 14, 15, and 9, respectively.

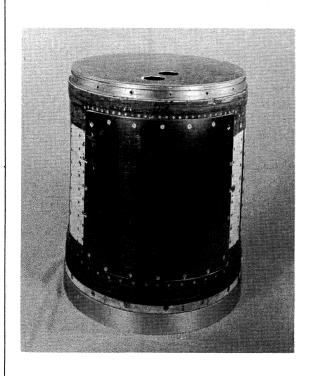
Fig. 10. Instrumentation section of rocket with structural access door in place.

Figures 10, 11, and 12 are three different views of an unpainted instrument section.

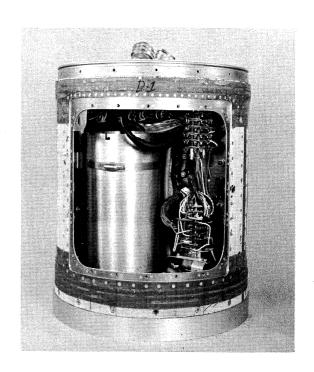
Fig. 11. Instrumentation section with door removed to show access to instruments. Three such doors are provided which are positioned so they can be opened in the launching tower.

- b. The instrumentation section was divided into three compartments. Compartment 1 contained the DOVAP Transponder, arm-disarm relay, and programstepping relay (Fig. 11). Compartment 2 contained the timer, Cutoff Receiver and Radar Beacon. Figure 12 shows this compartment with the above-mentioned units removed. Items contained in the third compartment were the flash-detector-amplifier-telemeter modulator unit and several battery packs. Figure 16 shows this compartment without the Cutoff-Receiver battery pack. Each of the three compartments contained, in addition, one of the three Kodak Ektron photosensitive cells, which were used as the flash detectors. The mounting bracket for one of these is shown in the upper left hand corner of Compartment 3 in Fig. 16.

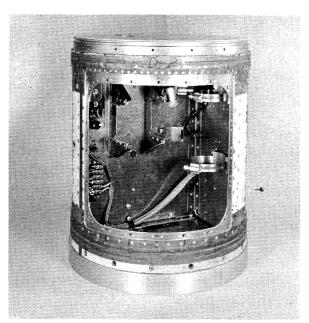
Fig. 12. Instrumentation section prior to installation of equipment. All sheet-metal parts are designed as structural members of the complete unit.

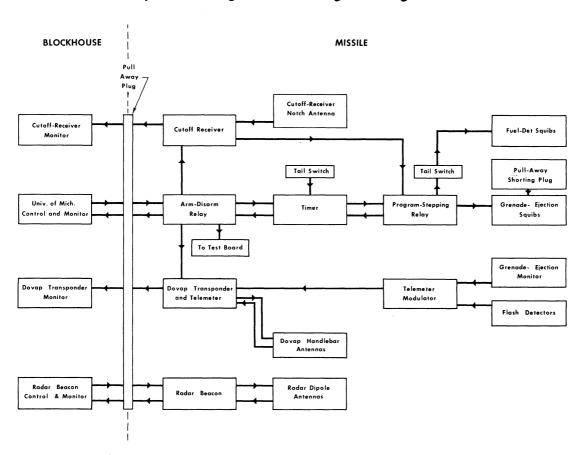
Fig. 13. Pre-IGY grenade-rocket circuit-block diagram.

The pre-IGY grenade-rocket circuit-block diagram is shown in Fig. 13. This diagram explains functionally the operation of the rocket electrical equipment.

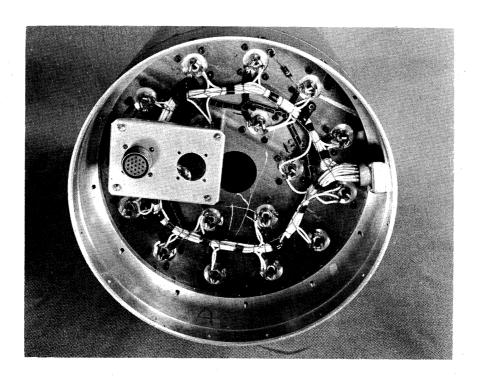
Fig. 14. Bottom of grenade section showing grenade squib wiring.

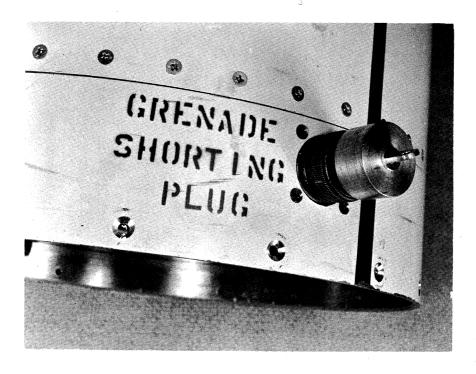
Fig. 15. Grenade section showing pull-away shorting plug in position.

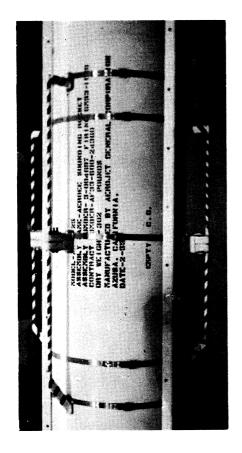
Fig. 17. DOVAP handlebar antennas, Aerobee SM1:01.

- c. The main body of the missle contained the ${\tt DOVAP}\,$ handlebar antennas (Fig. 17) and the through missile wiring.
- d. The tail section contained the tail-junction box, fuel-line detonator block, tail switches, Cutoff-Receiver notch antenna, and Radar Beacon dipole antenna. Figure 18 shows these two antennas installed on the tail fins of the rocket.

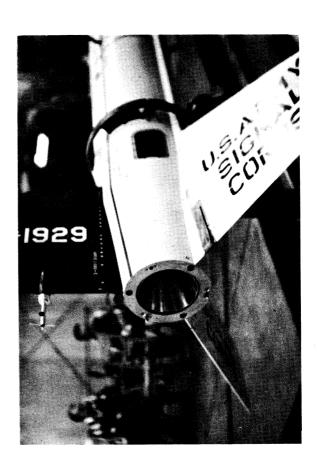
Fig. 16. Compartment 3 of the instrumentation section. Mounting bracket for

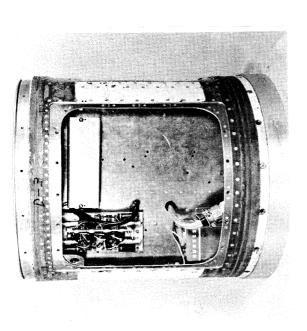
Fig. 18. SMI:01 tail section showing radar dipole antenna and Cutoff-Receiver notch antenna

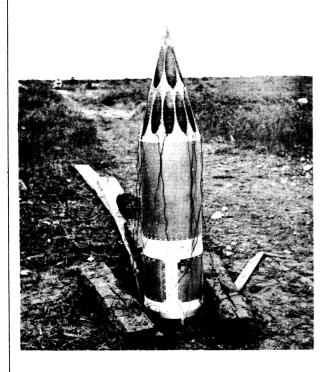
Fig. 19. Complete warhead after successful 18-round test. Shrapnel damage was light and confined predomi-Lanyards can be seen draped down the sides of the warhead. Approximately 5 feet of lanyard is consumed in the grenade explosion.

Eighteen grenades were fired from a completely assembled warhead with 100 percent success. Shrapnel damage was confined largely to the inside of the mortar barrels, with a few scattered nicks in the wooden nose cone. (Figure 19 shows the nose cone, grenade section, and instrumentation section after the test.) Except for some mortar replacements the entire unit was reusable. The largest piece of shrapnel that could be found is shown in Fig. 20.

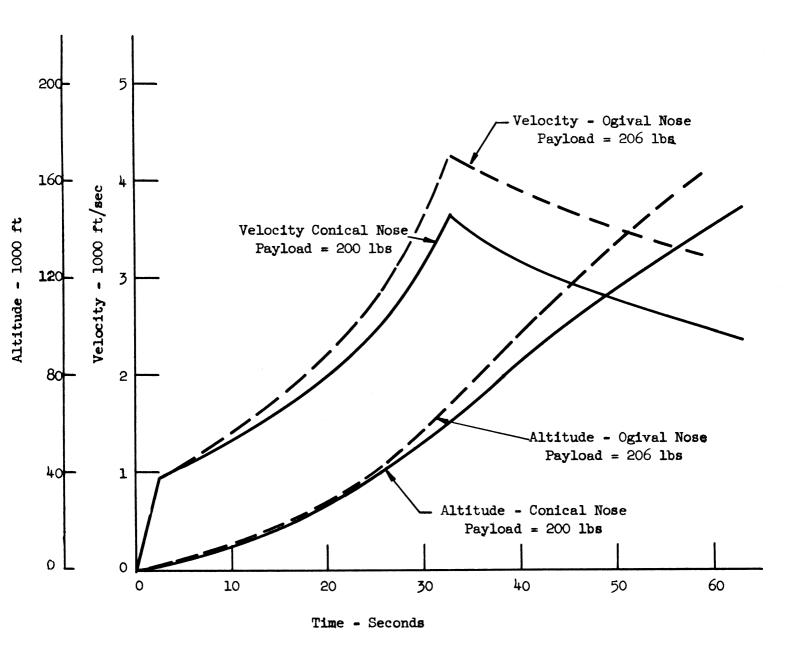
Summit Altitude (Ogival Nose) = 63.1 Mi Summit Altitude (40° Conical) = 44.5 Mi

Fig. 1. Variation of Velocity and altitude with time using ogival and conical nose comes (Aerobee AJ10-25).

Figure 1 shows a time history of velocity and altitude up to the point of negligible drag.

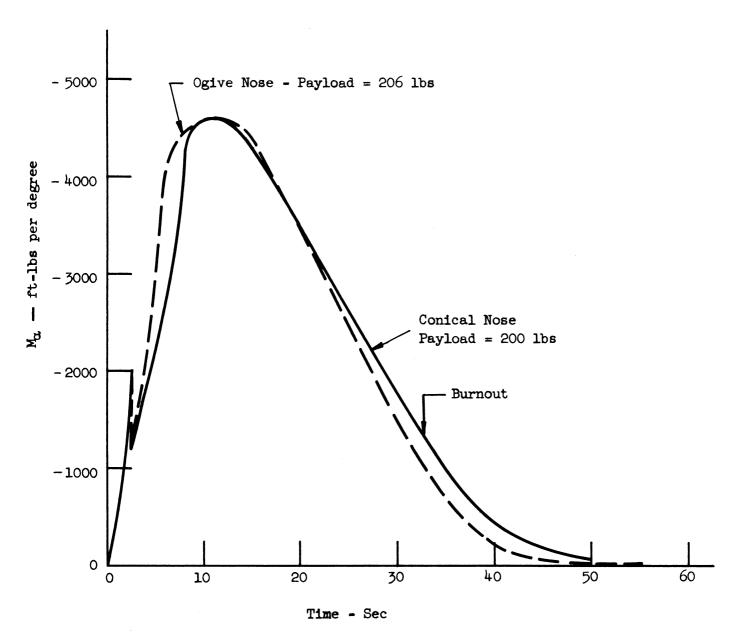
Thrust at S.L. = 4100 lbs Specific Impulse = 195 Launching Elevation = S.L.

Fig. 2. Variation of M_{CL} with time using ogival and conical nose cones (Aerobee AJ10-25).

The static stability at burnout expressed by $M_{\rm C}$ (see Fig. 2) using either a conical or ogival nose is considerably above that estimated for models which have made successful flights. Note that the conical nose improves the stability slightly after 20 seconds of flight and during the critical period near burnout.

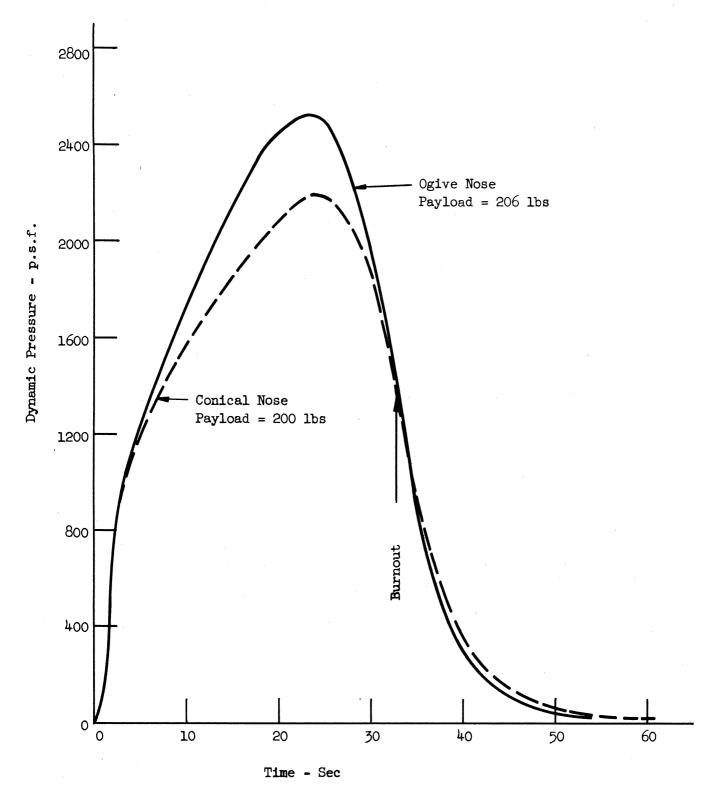
Fig. 3. Variation of dynamic pressure with time using ogival and conical nose cones (Aerobee AJ10-25).

The variation of dynamic pressure and center of gravity with time are shown by Figures 3 and 4 respectively. These are included to aid in the evaluation of static stability.

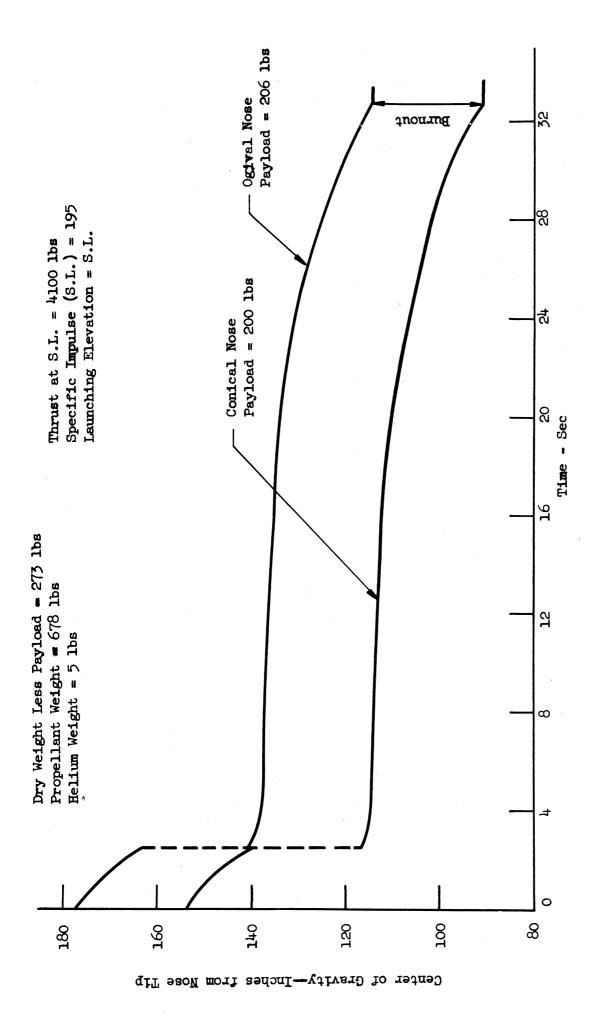
Fig. 4. Variation of center of gravity with time using ogival and conical nose cones (Aerobee AJ10-25).

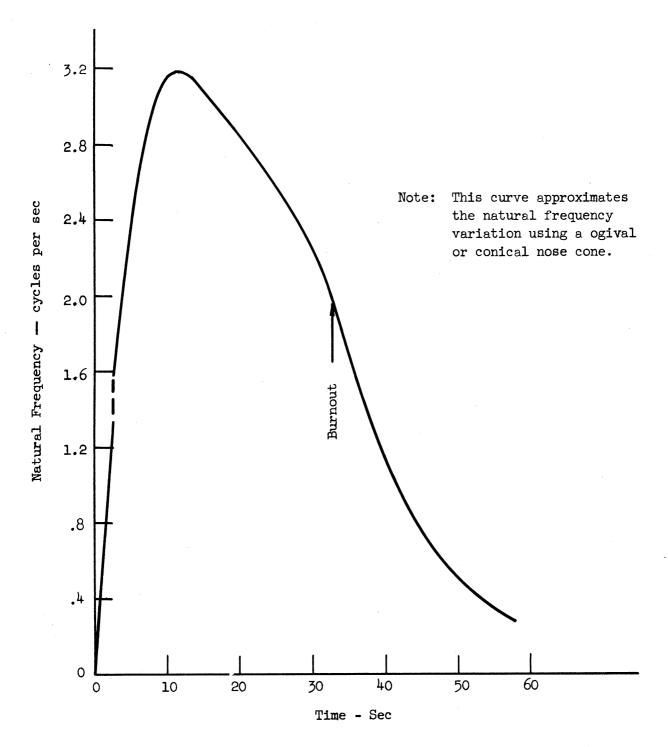
Fig. 5. Variation of natural frequency with time (Aerobee AJ10-25).

Assuming a rigid vehicle, the natural frequency in pitch due to aerodynamic loading was computed. (Refer to Figure 5.) As the shape of the nose did not appreciably effect the natural frequency, only one curve is shown. Flights of some previous models have indicated coupling between the frequency in pitch and spin at or near burnout when the frequency was between one half and one cycle per second. The occurrence of the undesirable effects of coupling appear less likely for this model as the frequency in pitch near burnout is 2 cycles per second.
