THE UNIVERSITY OF MICHIGAN

Technical Report No. 03424-20

FURTHER CAVITATION DAMAGE CHARACTERISTICS  
IN A CAVITATING VENTURI USING WATER  
AND MERCURY AS TEST FLUIDS

September, 1966

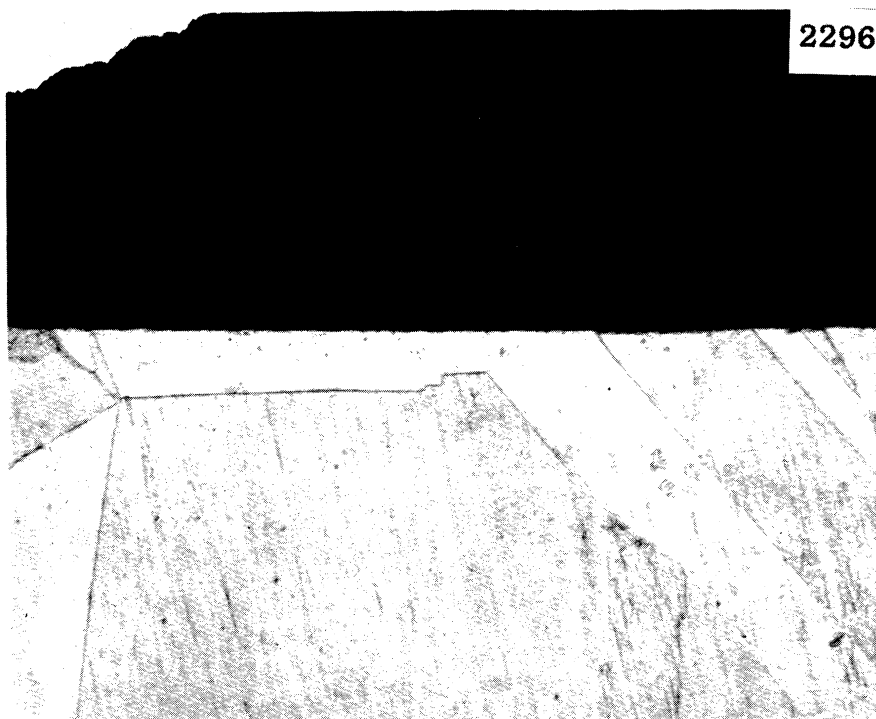
Fig. 11.--Photomicrographs of surface of specimen #CZ-229 (copper-zinc alloy, 1400°F anneal, 1 hour) after 100 hours exposure to "standard cavitation" in water (80°F) at a throat velocity of 200 feet per second. Magnification 250X. (a) Unetched, (b) Etched.

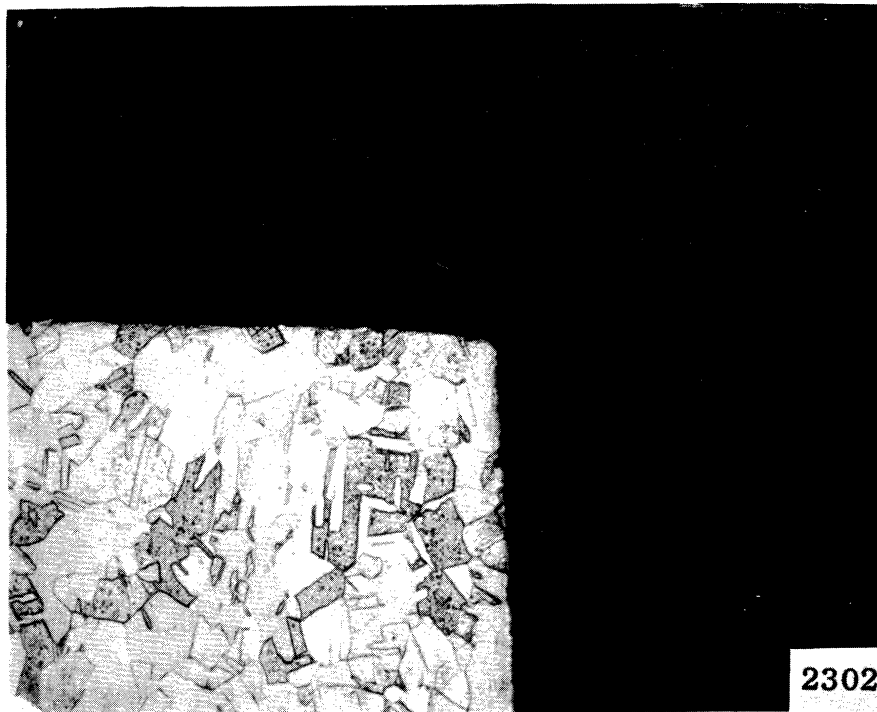
Fig. 14.--Photomicrographs of corner of specimen #Cu-83 (copper, 900°F anneal, 1 hour) after 100 hours exposure to "standard cavitation" in water (80°F) at a throat velocity of 200 feet per second. Magnification 250X. (a) Unetched, (b) Etched.

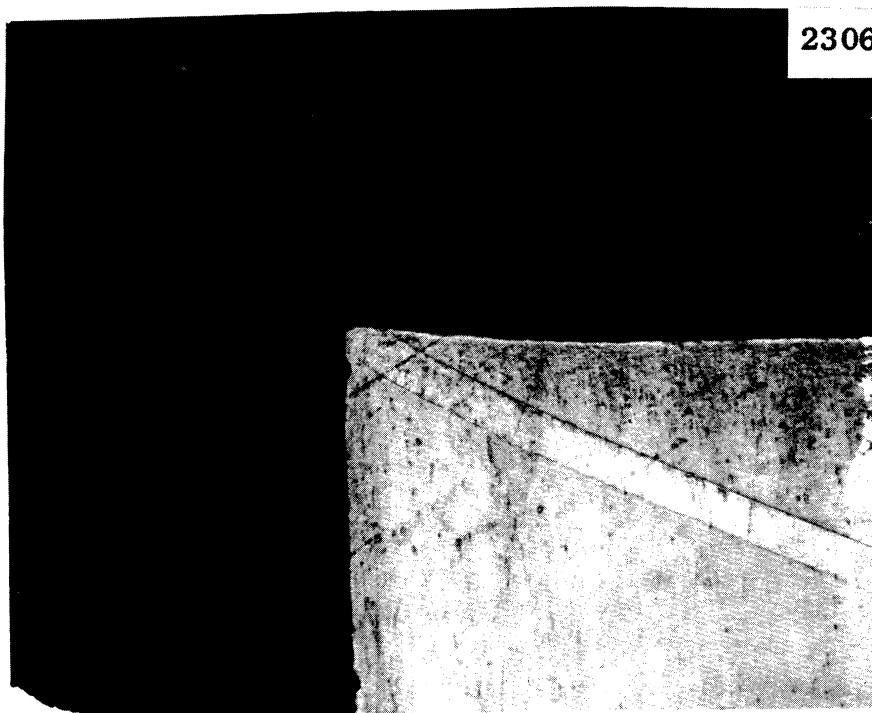
Fig. 16.--Photomicrographs of corner of specimen #Cu-157 (copper, 1500°F anneal, 1 hour) after 100 hours exposure to "standard cavitation" in water (80°F) at a throat velocity of 200 feet per second. Magnification 250X. (a) Unetched, (b) Etched.

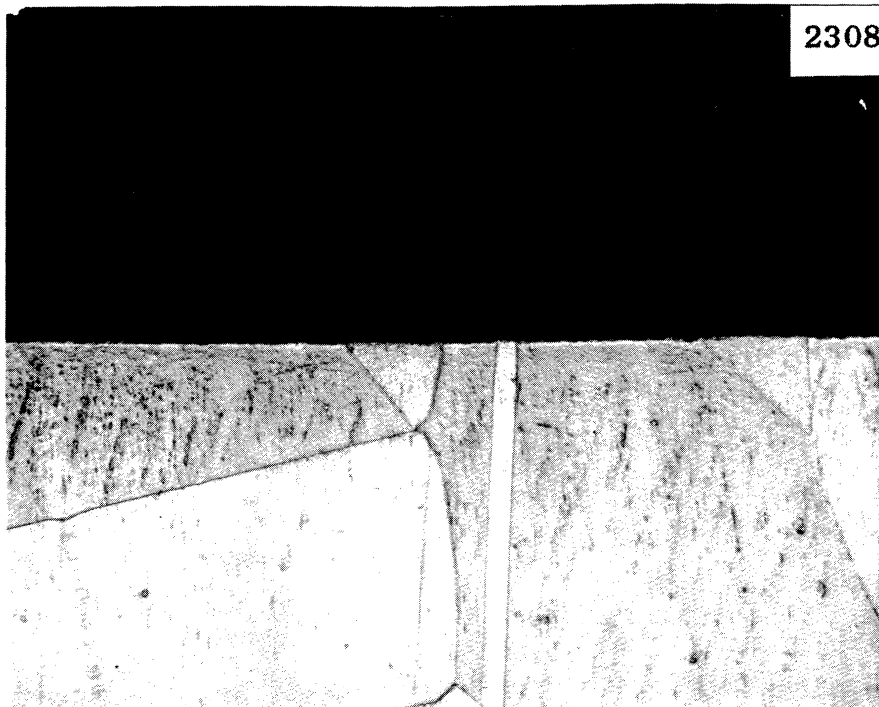
Fig. 17.--Photomicrographs of surface of specimen #Cu-157 (copper, 1500°F anneal, 1 hour) after 100 hours exposure to "standard cavitation" in water (80°F) at a throat velocity of 200 feet per second. Magnification 250X. (a) Unetched, (b) Etched.

boundaries has been noted, as seen most clearly in Figure 17, for the high heat-treat pure copper. The bump appearing on the surface in Figure 19 is believed due to improper handling of the specimen. There is little else to be concluded from the rest of these photomicrographs except verification of the points already made. However, they do record the grain structure of the cavitated specimens, the weight loss of which has been reported elsewhere,<sup>3,4</sup> and thus have been included here.

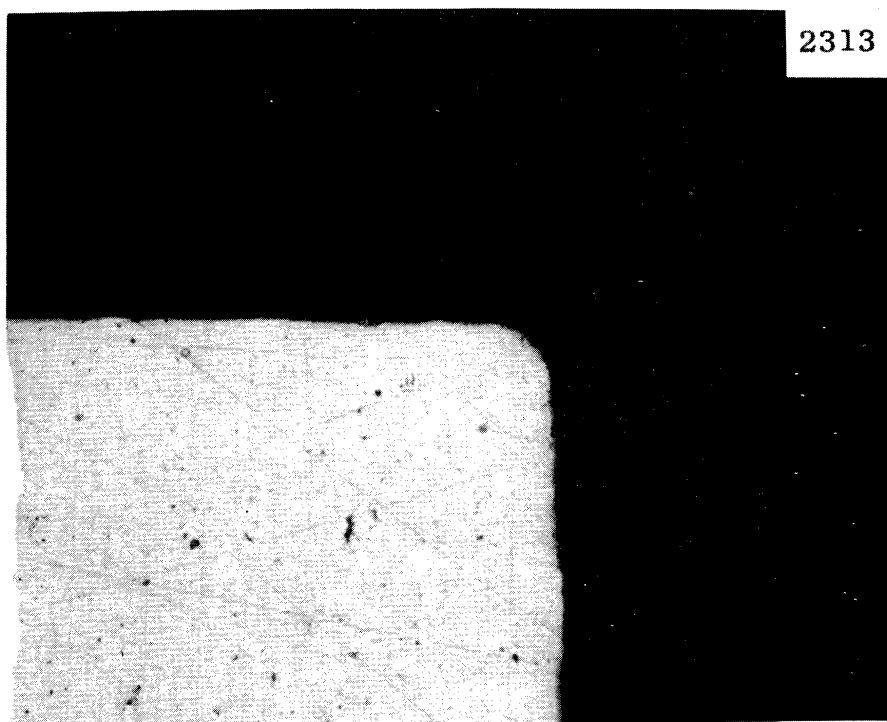
Fig. 20.--Photomicrographs of corner of specimen #Cu-Ni-84 (copper-nickel alloy, 1300°F anneal, 1 hour) after 100 hours exposure to "standard cavitation" in water (80°F) at a throat velocity of 200 feet per second. Magnification 250X. (a) Unetched, (b) Etched.

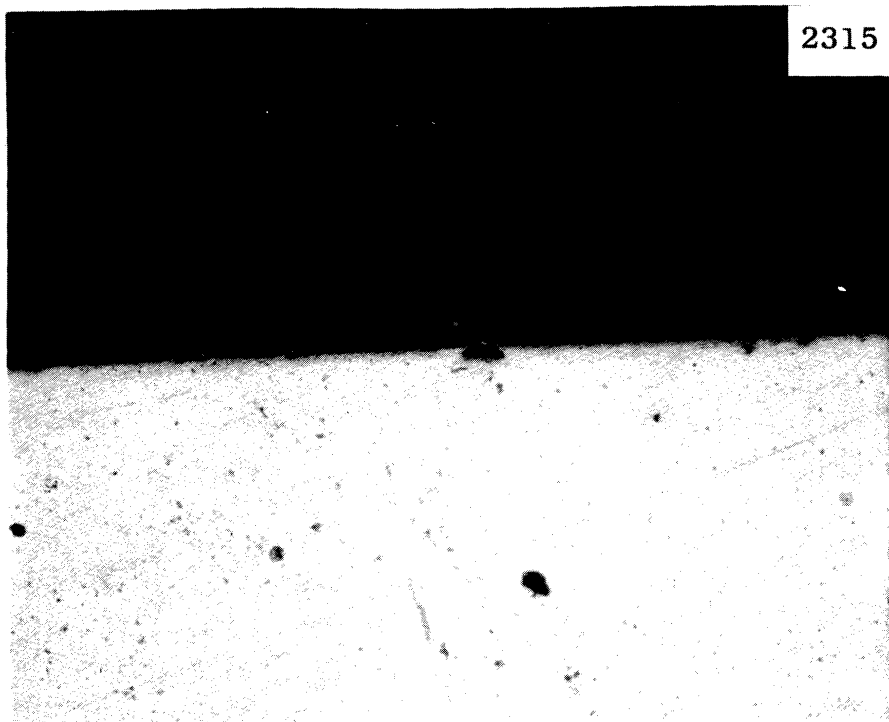
Fig. 21.--Photomicrographs of surface of specimen #Cu-Ni-84 (copper-nickel alloy, 1300°F anneal, 1 hour) after 100 hours exposure to "standard cavitation" in water (80°F) at a throat velocity of 200 feet per second. Magnification 250X. (a) Unetched, (b) Etched.

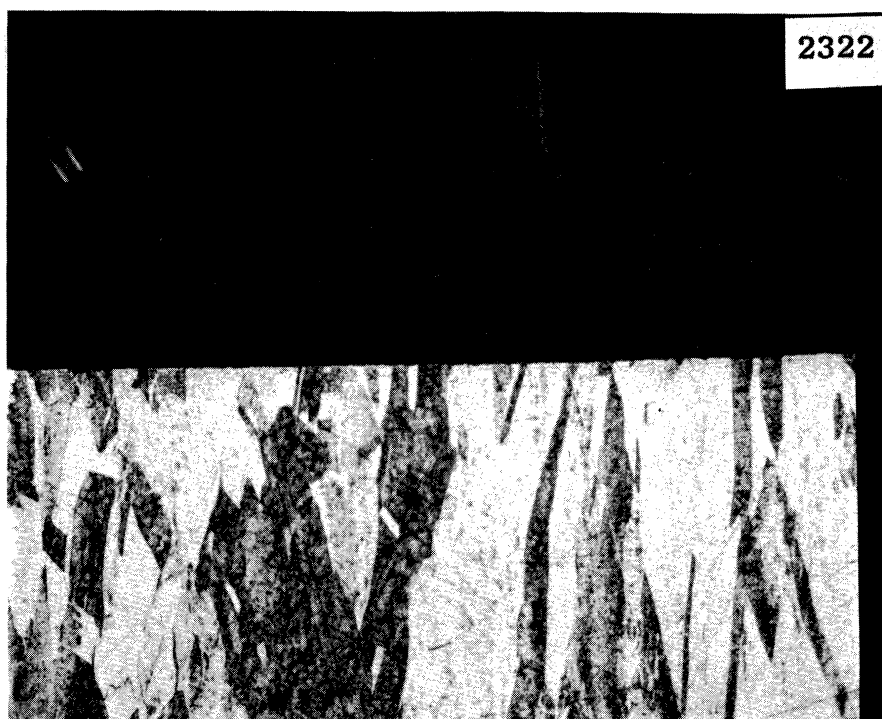
Fig. 25.--Photomicrographs of surface of specimen #N1-11 (nickel, 75% cold-worked) after 100 hours exposure to "standard cavitation" in water (80°F) at a throat velocity of 200 feet per second. Magnification 250X. (a) Unetched, (b) Etched.

A cavitation test specimen representing each of the three heat-treat states of these alloys was sectioned. Photomicrographs were then made of a region including the surface from the center portion of the specimen and one showing the corner. An unetched and an etched photomicrograph were taken of each area, although the same exact location was not covered in each instance. Figure 6 shows a typical blunting of the edge of a specimen, which is thought to be due to handling and does not represent any weight loss. In the following photomicrographs, only slight damage can be seen although the magnification is about 250X. This is due to the fact that the pits are typically on the order of 0.05 mils in diameter, with a depth to diameter ratio of approximately 0.03.<sup>4</sup> Therefore, at this magnification, a typical pit would be only about 0.4 mils deep at the scale of the photograph and about 0.0125 inches across, so that it would be difficult to see. However, a close examination of most of these cross-section photomicrographs does show such pitting (Figures 6, 7, 9, etc.), and previously reported photomicrographs of the surface itself show substantial pitting on similar specimens.<sup>4</sup> Figure 30 is typical, also showing proficorder traces of the surface. Figure 9, for example, also shows considerable distortion of the surface layer which has been somewhat cold-worked by the cavitation attack. This often results in a measurable increase in surface hardness as verified in an earlier report.<sup>4</sup> No preferential attack along the grain

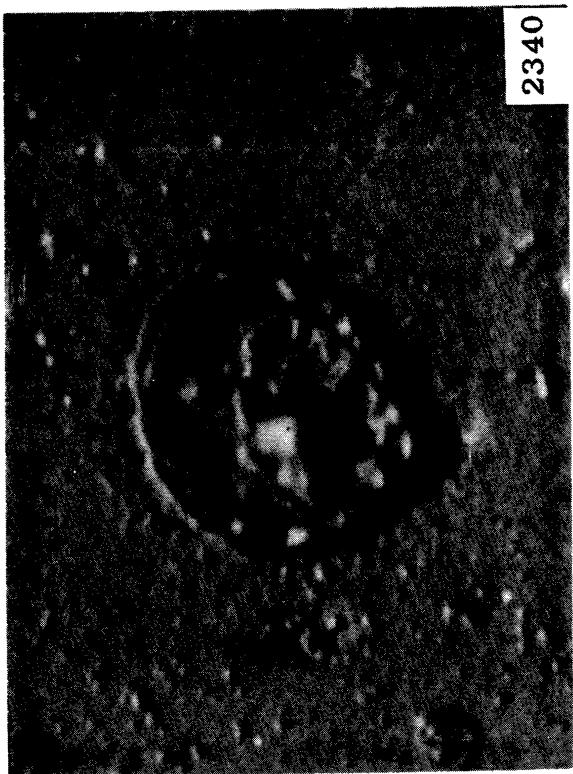
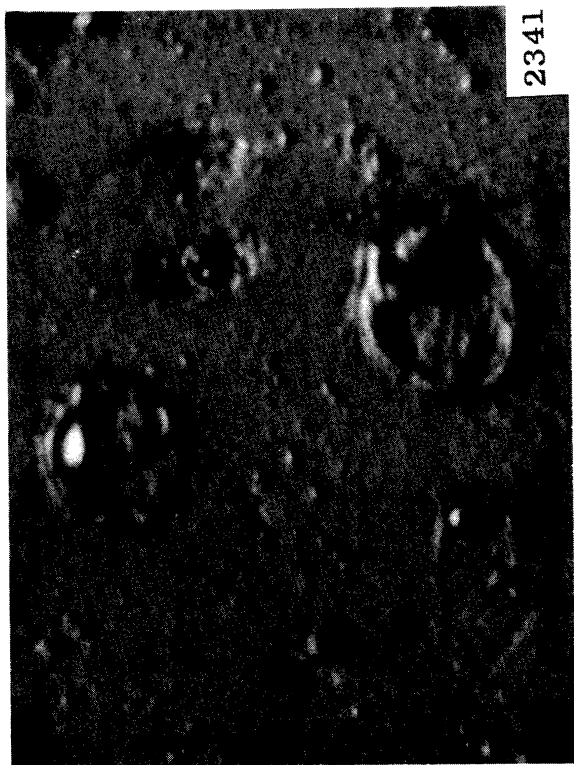
Fig. 37.--Photomicrographs of surface of specimen #P-6 (plexiglas) after exposure to "standard cavitation" in water at a throat velocity of 200 feet per second. Magnification 2000X.

cavitation case would be about 0.25 mils. Figures 35, 36, and 37 show the same pits photographed at the increasingly larger magnifications of 500X, 1000X, and 2000X, respectively, so that more detail of the individual pits can be obtained. The photomicrographs appear to show craters with raised approximately symmetrical rims, and a somewhat off-center deeper central pit. The actual rim diameter is about 0.5 mils. The area immediately surrounding the central pit, presumably created by the impingement of the microjet, appears undamaged out to the rim, which is apparently divided into many small segments. No precise detailed mechanism to explain the detailed pit shape is available. However, it does seem more consistent with the microjet hypothesis than with the impingement of shock waves from a collapse point off the surface as required by the classical Rayleigh collapse hypothesis.

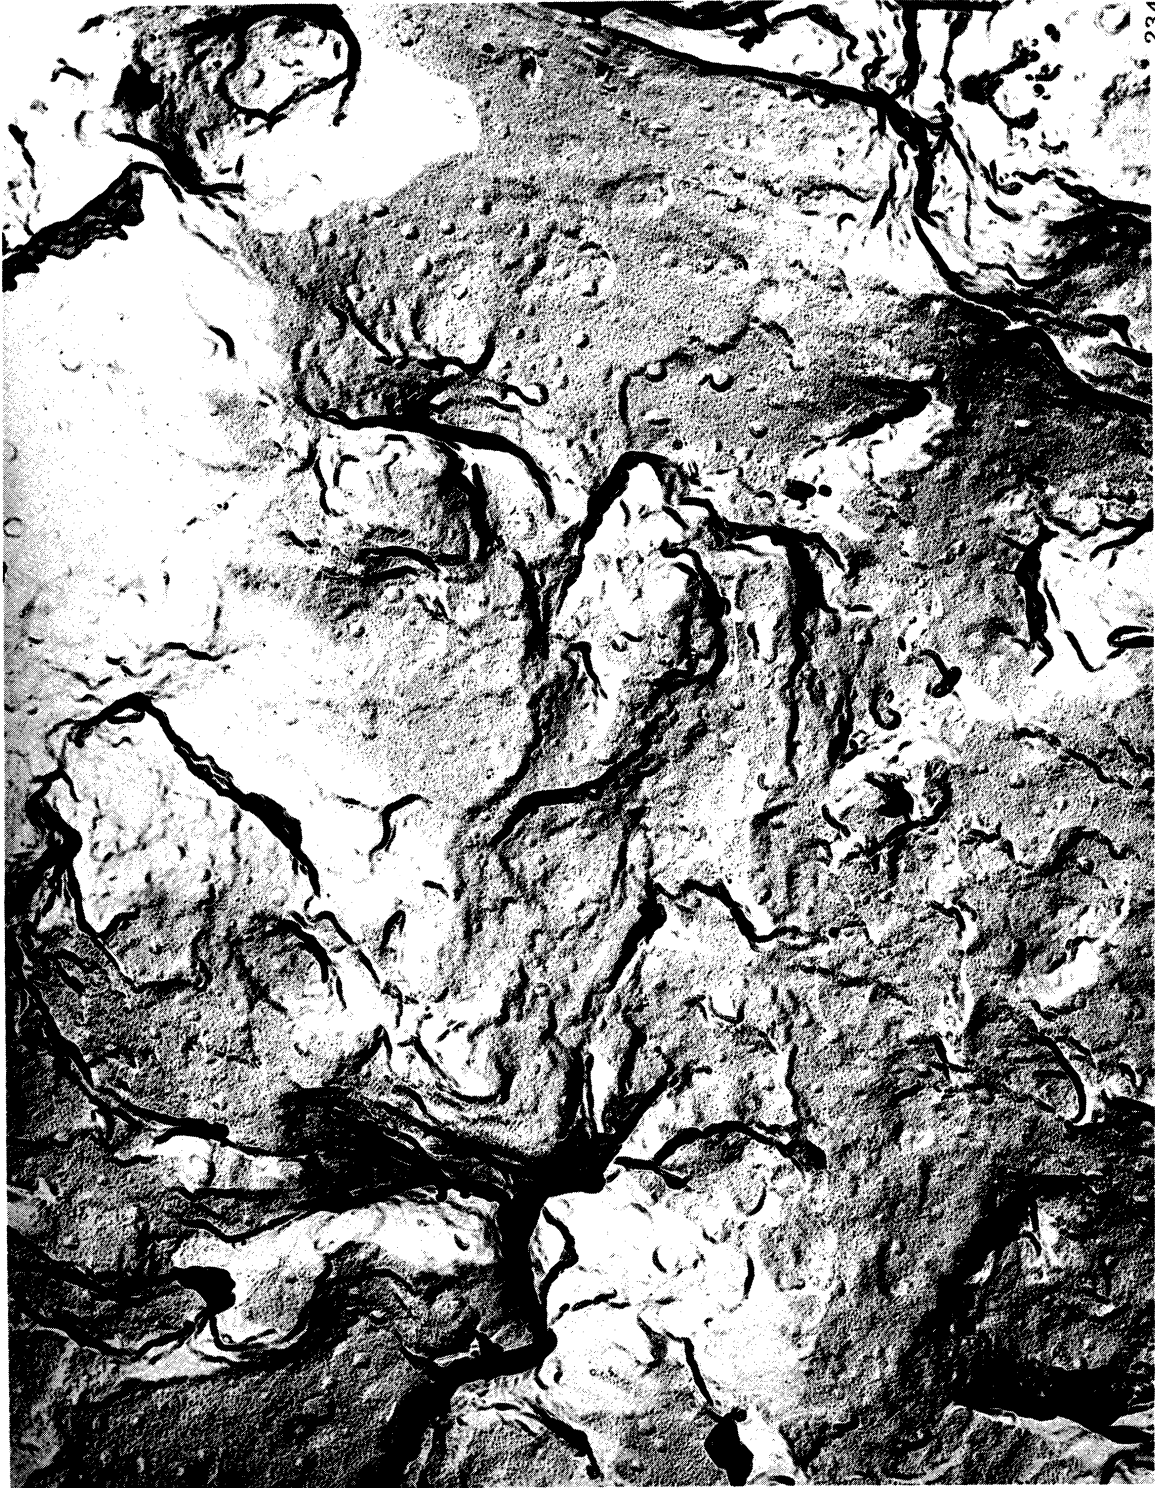
Fig. 40.--Electron photomicrograph of surface of type 304 stainless steel specimen subjected to cavitation damage in mercury for 1 hour in the ultrasonic facility. Magnification 60,000X.

had been subjected to a cavitation field in mercury for one hour with an ultrasonic vibratory horn device, which has been used extensively in this laboratory for cavitation damage studies.<sup>5,etc.</sup> Initially the specimen surface was of "as machined" texture (not ground or lapped). While the detail obtained (Figures 38, 39, 40, and 41) is very good, it is difficult to interpret. This difficulty arises because of the very high magnification of 60,000X, and due to the present lack of any reference photographs of similar undamaged surfaces.

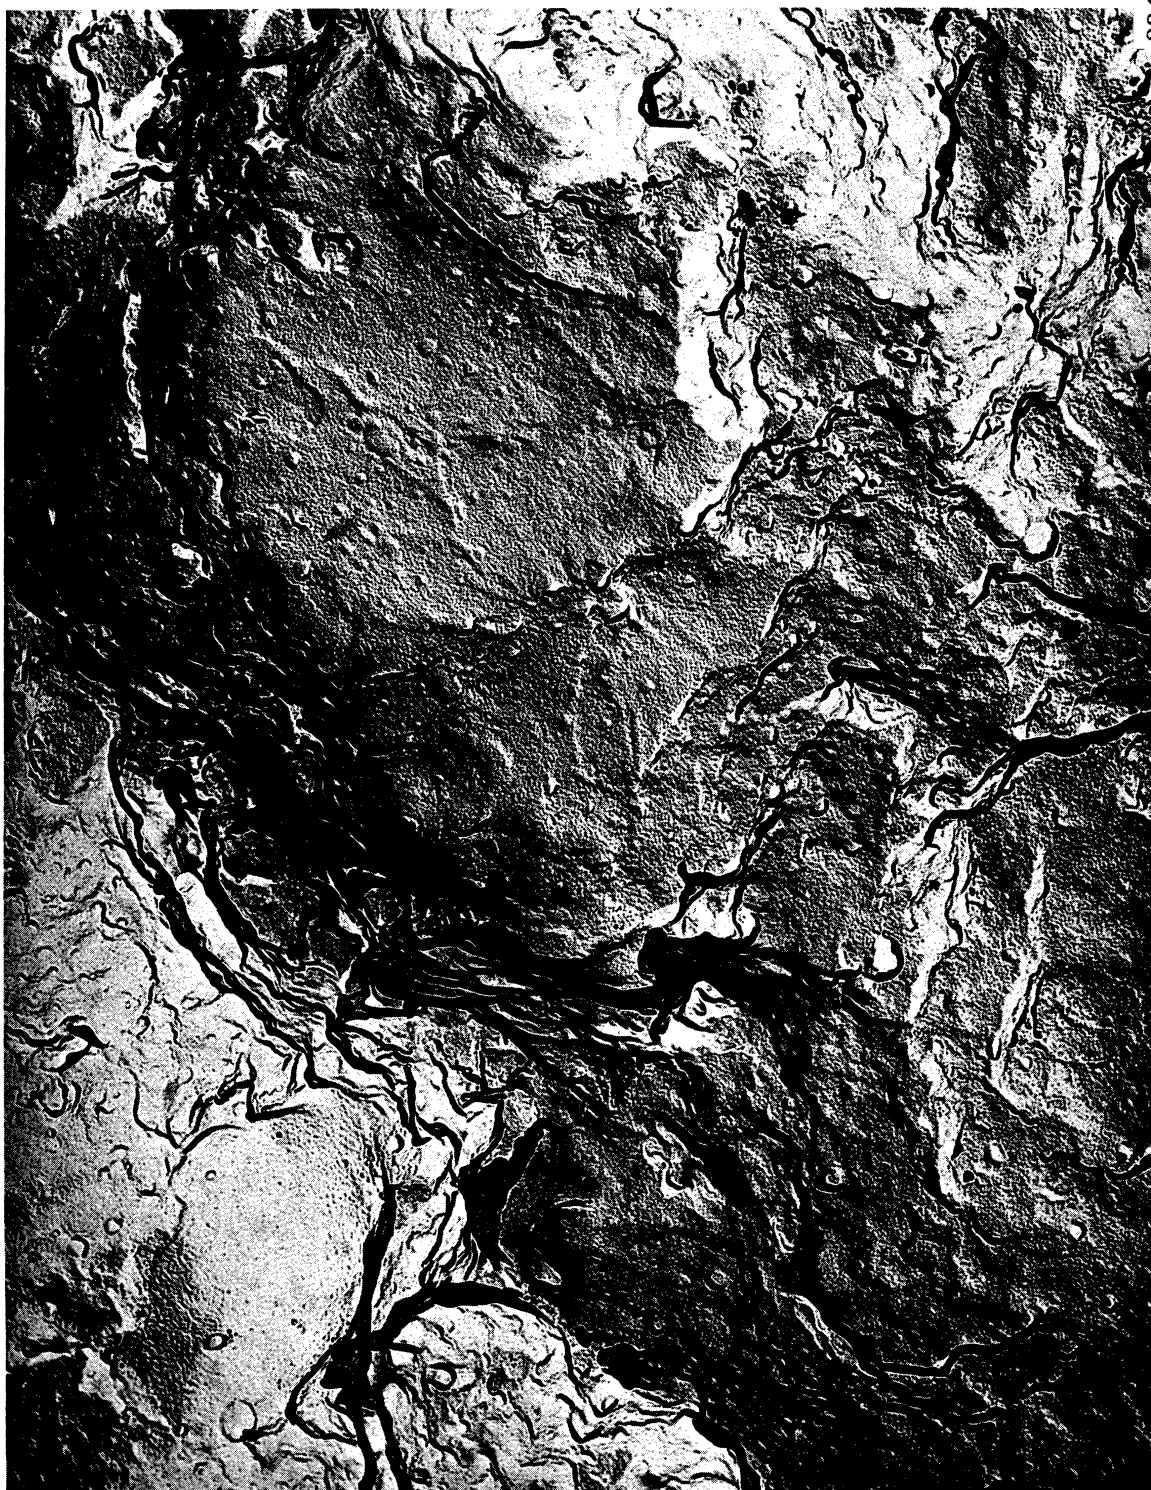
Fig. 41.--Electron photomicrograph of surface of type 304 stainless steel specimen subjected to cavitation damage in mercury for 1 hour in the ultrasonic facility. Magnification 60,000X.
