Damage Progression in Compressively Loaded Laminates Containing a Circular Cutout

A. M. Waas*

C. D. Babcock Jr.† and W. G. Knauss‡

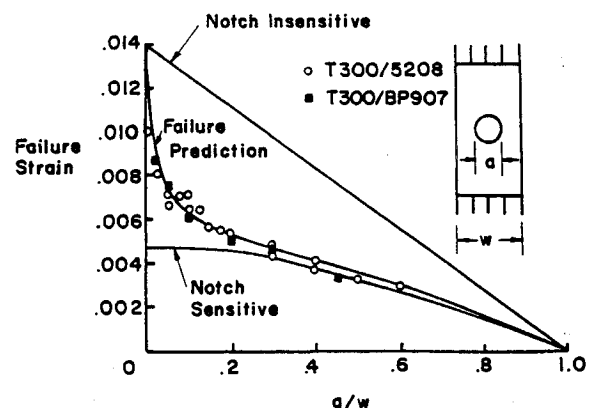
Fig. 1 Summary of test results for T300/BP907 and T300/5208 composite laminates: $w = 13$ cm (from Ref. 1)

The open hole strengths of these laminates has been the subject of numerous investigations.¹⁻⁴ Figure 1 depicts the ultimate load carrying capacity of these laminates as a function of the normalized hole diameter. Mikulas⁵ has shown that these results could be bounded by simple criteria based on notch sensitivity. If the material is notch insensitive, the failure strains are directly proportional to the reduction in cross-sectional area, whereas if the material is notch sensitive, then it is postulated that the material fails when the strain concen-

tration at the hole edge equals the failure strain of the material. It is seen that the latter assumption is too conservative in that the failure strain is underestimated for a/w ratios < 0.4 . This situation indicates the possibility that the strain concentration effect alone cannot possibly account for the failure process. Based on this premise, Starnes and Williams¹ carried out open hole strength testing of these laminates and reported a shear crippling type of failure to be prevalent in the vicinity of the hole prior to catastrophic failure. This conclusion was based on postmortem examination of damaged specimens.

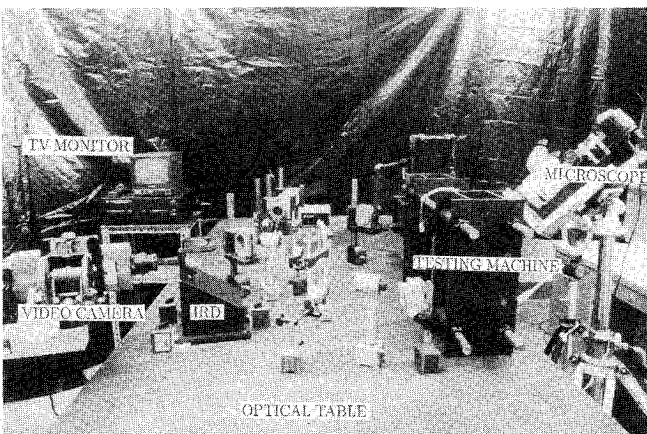
Fig. 2 Experimental setup.

Figure 2 is a photograph showing the arrangement of the various devices used in the experiment. On a pneumatically vibration isolated table, optical components are arranged to make a hologram and generate interferograms of the test specimen, which is loaded by a table top compression device. An optical microscope is mounted on a tripod that is situated adjacent to the optical table by the testing machine. A 35-mm motor driven single lens reflex camera attached to the microscope is used to take photographs of the test specimen hole surface during the testing sequence. Recording and developing of the hologram is done on a thermoplastic plate that is housed in the body of the instant recording device (IRD), as marked in Fig. 2. This device, which is electronically controlled, replaces the conventional wet chemical processes that are used if the recording is done on a photographic plate. A video camera placed behind the thermoplastic plate views the test specimen through the hologram. A VCR records the interferometric pattern generated during the loading sequence. A television monitor is used to view the interferograms during a typical test, which enables testing to be done interactively. In the following sections, the main components of the experiment are described.

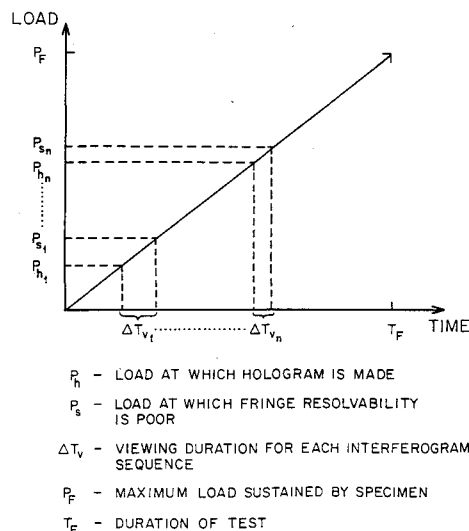
Fig. 4 Experimental procedure for generating interferograms.

sists of the beam splitter, a beam expander-spatial filter, and a collimating lens). The corresponding load is P_1 (refer to Fig. 4). A hologram is then recorded by exposing the thermoplastic plate positioned at the junction of the reflected light and reference beam. On completion of the first exposure, the specimen that is continuously loaded is viewed through a camera attached to a VHS recording system (a VCR and a monitor). The resulting image consists of fringes that are dynamical in nature representing contour maps of the changes, with respect to the state S_1 , of the out of plane displacement component w of the stressed specimen. These fringes, together with the load cell reading are recorded. The load cell reading is obtained by focusing the display of the voltmeter, exhibiting the load cell reading, at the position of the circular hole in the plane of the test specimen. With increasing load on the specimen, the fringe density becomes high, so that the resolution of the interferogram becomes poor. At this stage, a new hologram of the test specimen is made and the cycle of events is repeated. Thus, at the end of each experiment, we obtain an interferometric recording of the complete load vs out-of-plane displacement history of the specimen. This sequence of events is depicted in Fig. 4.

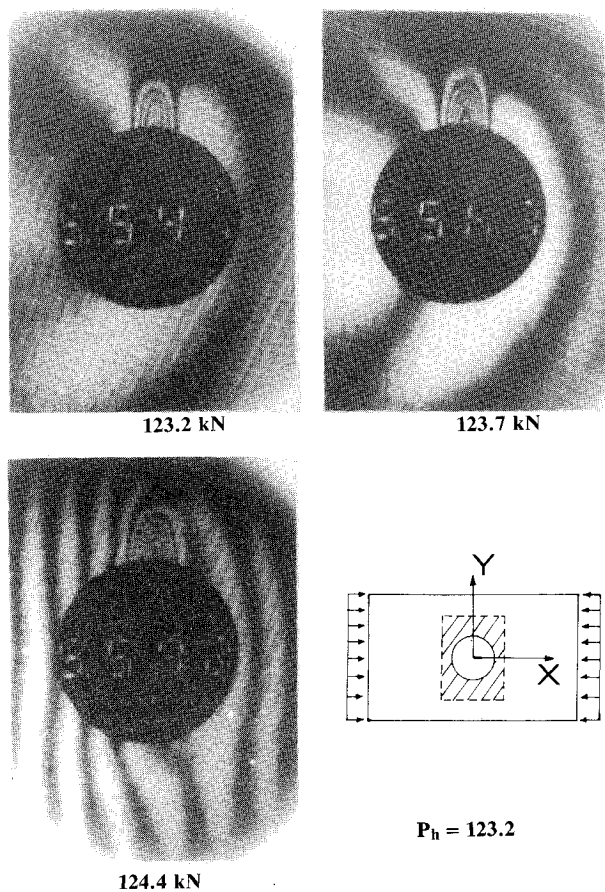
Fig. 5 Initiation of damage (specimen TB11).

Figure 5 shows a series of interferometric patterns of a type B specimen that correspond to the first instance at which internal damage was detected. In these interferograms, the axis of loading is horizontal. The numbers below each picture represent the load in kilo Newtons $[(4.448 \times 10^3)]^{-1} \text{ lbf}$ corresponding to each frame, whereas P_h indicates the load at which the hologram was made for that particular set of frames (reference load). Notice the highly localized fringe cluster adjacent to the hole edge at approximately 90 deg to the loading direction. When any form of internal damage occurs that manifests itself as a localized perturbation in the normal displacement component w , the resulting interferometric patterns display this event as shown in this figure. A view of the hole surface corresponding to this fringe pattern is shown in frame 2 of Fig. 6. Notice the damage to the midplane 0 deg plies, which appear as a black spot. Adjacent to this spot is a delamination crack. Inspection of the photomicrographs prior to this event revealed no damage to the hole surface. In all of the experiments conducted, it was always revealed that a perturbation in the interferometric data corresponded to 0 deg ply damage at the hole surface. This interferometric pattern is interpreted as a localized bulging of the surface just above the damage site. This localized damage to the 0 deg plies is found to be the triggering of extensive delamination cracking and

localized buckling of the delaminated portions that follows subsequently. This sequence of events is observed consistently in all of the type B specimen. At this stage, it is pointed out that the word damage is used to describe any form of destruction to the specimen caused by the application of mechanical load as picked up on the interferograms. The interferograms corresponding to the initiation event reveal the displacements within the damage zone to be increasing with increasing load. This is clear by noting a sharp increase in the fringe density within the damage zone as loading proceeds. Subsequent to the initiation, the remaining 0 deg plies undergo failure while delamination are seen to appear between various ply interfaces. An inspection of the sequence of photomicrographs in Fig. 6 shows this. The delamination undergo a stage of slow growth, as shown in the next set of interferometric patterns (Fig. 7). Here, the reference state corresponds to a load $P_h = 159 \text{ kN}$ while the three frames span a load increase ΔP of 1.73 kN. The displacement patterns extracted from the interferograms in Fig. 7 are shown in Fig. 8. Here, the displacements are measured with respect to displacements in areas remote from the hole edge. The origin of the axes is placed at the edge of the hole as indicated. The X and Y axes are scaled, whereas the vertical Z axes, representing Δw , is 1:1. The fringe patterns in Fig. 7 reveal the displacements to be growing faster within the damage zone than the rest of the specimen. Further, the damage area is also seen to grow, indicating that the delaminated portions are spreading outward approximately at right angles to the direction of the applied load. The corresponding photomicrographs (Fig. 6) show the extent to which delamination cracking occurs. Notice the zero fiber breaks as well as the large (on the order of ply thickness) mode I type displacements. These observations lead us to conclude that delamination buckling is the mechanism chiefly responsible for the spreading of the damage to the undamaged areas of the plate. Once the delaminated portions reach a sizable extent, an increase in the growth rate is noticed. This is shown in the last series of interferograms (Fig. 9). In these, the fringe density within the damage zone is very high, so much so that the resolution of the interferogram within this area is poor. However, the manner in which these delaminations grow and respond

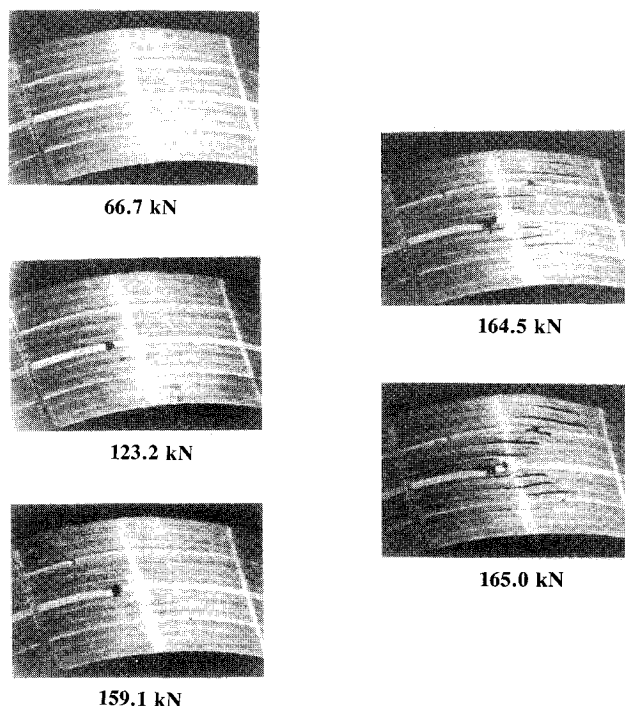
Fig. 6 Hole surface photomicrographs of specimen TB11 (type B).

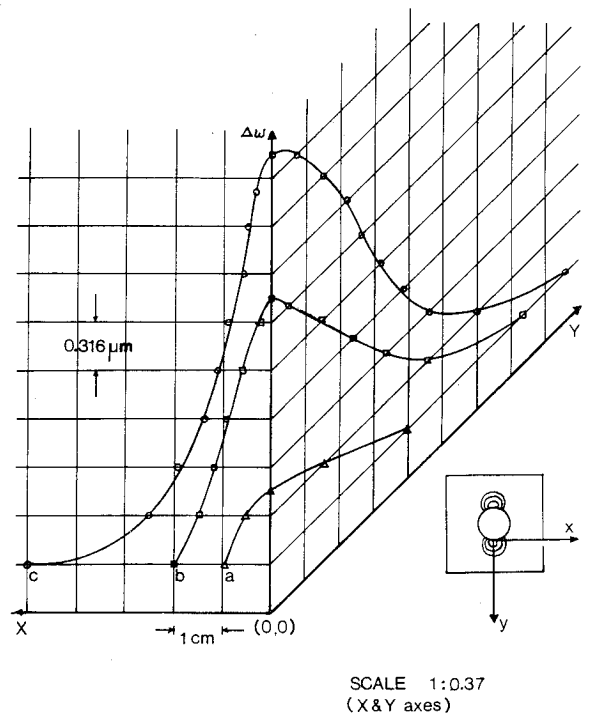
Fig. 8 Summary of displacements corresponding to Fig. 7.

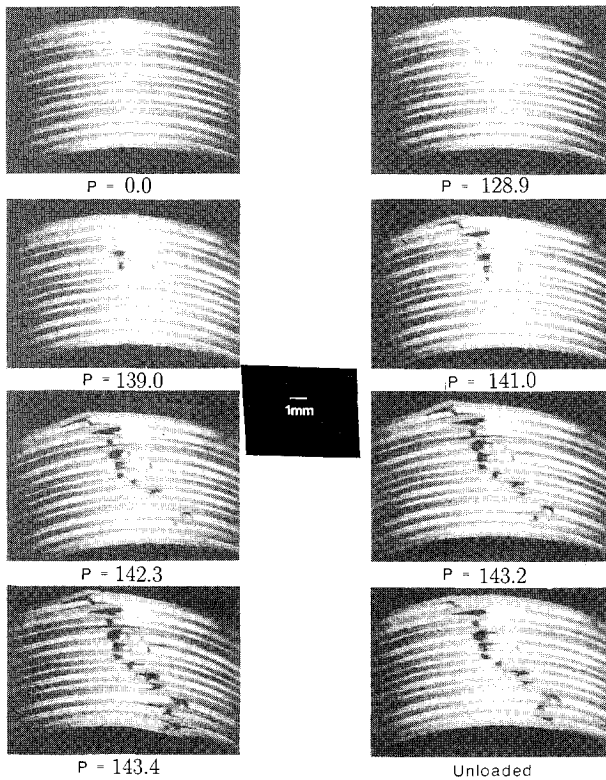
Fig. 10 Hole surface photomicrographs showing damage progression (specimen TB17).

damaged, unloaded specimen is shown in the last frame of Fig. 10.

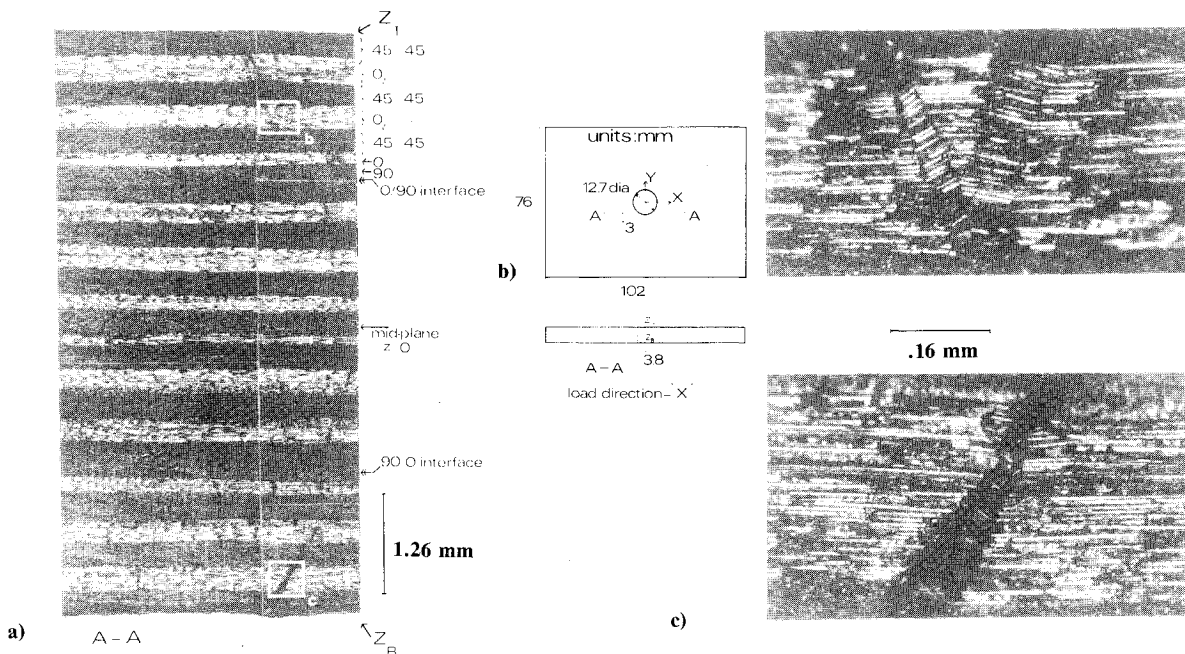
Fig. 12 Internal damage at the vicinity of the hole (specimen TB15): a) entire cross section; b) complementary kink in second 0 deg layer from top; and c) magnified view of damage to bottom 0 deg layer.

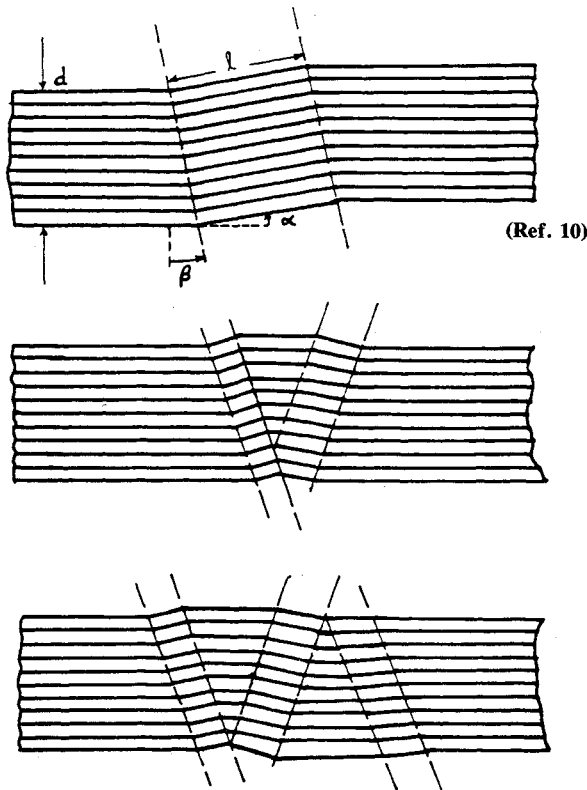
Fig. 13 Geometry of typical kink bands.

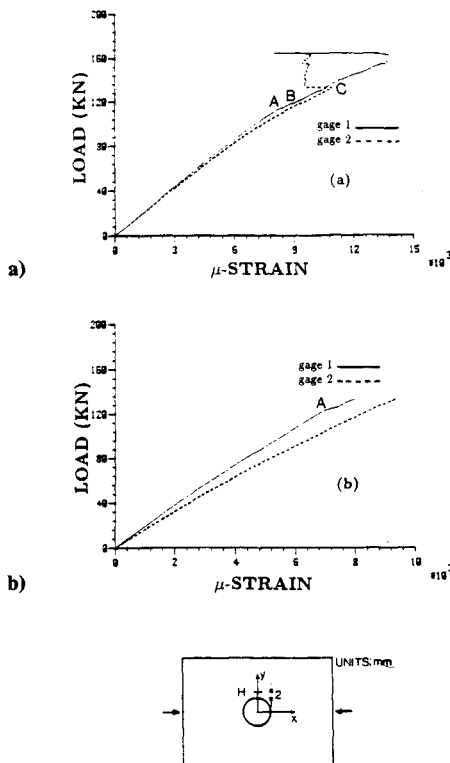
Fig. 14 Strain gauge response for specimens: a) type B (specimen IM28); and b) type A (specimen IM21).

puts from the Wheatstone bridge were sent through an amplification stage and fed into an in-house computer for manipulation. Strain-load plots typical of type A and B specimens are shown in Fig. 14. In these figures, the response of the strain gauges, near the hole edge (location H) is shown. Notice that the strains are seen to increase linearly with increasing far-field load. When the far-field load reaches P_i (corresponding to damage initiation within the 0 deg plies), the load vs strain behavior shows a kink (marked A), implying a localized softening. For the type B specimen (Fig. 14a), with failure of other 0 deg plies, the softening continues (marked B), until reaching C, when strain reversal is detected on one gauge. This reversal occurs because the delaminated portions closest to the surface on which the gauge is attached undergo local buckling. The buckling results in tensile strains on the outer surface, due to bending, causing a net reduction in the compressive strain. For type A specimen, beyond failure initiation, data can be collected only to the point where surface buckles form due to delamination. At this time, the large out of plane displacements encountered during the rapid propagation and growth of the delaminated portion result in the strain gauges being peeled off of the surface, disrupting the data acquisition. The average microbuckling strain for the two types of specimens are listed in Table 3.
