THE UNIVERSITY OF MICHIGAN

Cavitation and Multiphase Flow Laboratory

SOME EFFECTS OF APPLIED STRESS ON EARLY STAGES

OF CAVITATION DAMAGE

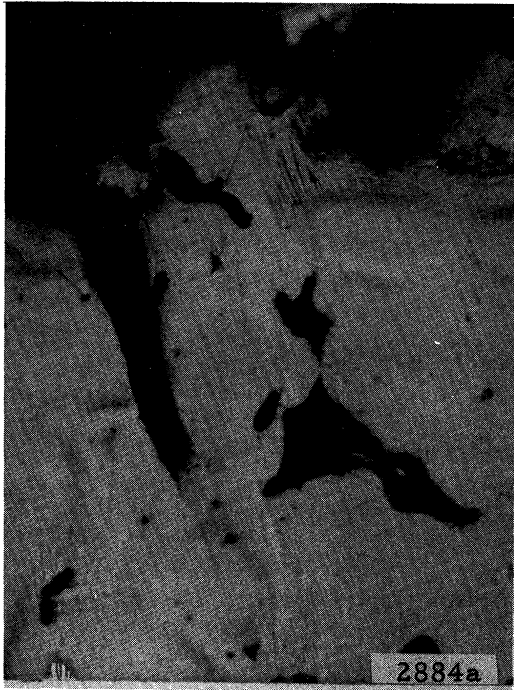
Figure 16. Photomicrographs of Cavitation Damage Area of Zero Load SAE 660 Vibratory Specimens (400x)

Fig. 16 is four photomicrographs of a damaged SAE 660 specimen, showing both transverse and longitudinal sections. The interior "holes" are porosity in the cast material. This specimen had been tested under zero applied load. In the section in the transverse direction (Fig. 16-a and b) only a few cracks are visible. Slip lines, however, can be seen in photograph A at the base of the pit on the top right. Slip lines are also visible in photographs B, C, and D, indicating that the material adjacent to the pits has experienced considerable cold work. In photographs A and B the slip lines appear almost perpendicular to the pit apex. (16)

The longitudinal photographs (Fig. 16-c and d) show some evidence of microcracks at the base of the pits. In the center of photograph D a large pit has at its apex a number of microcracks emanating in different directions. There are also slip lines on either side of the pitted region, and particularly to the right of the apex, indicating that considerable cold work was done in this region. Fig. 17 shows photomicrographs of an SAE 660 specimen tested under compressive load, while C and D are for a tensile specimen. In both stress modes the longitudinal pictures show the microcracks from the area of the pit apex running vertically to the surface, and the transverse (17)

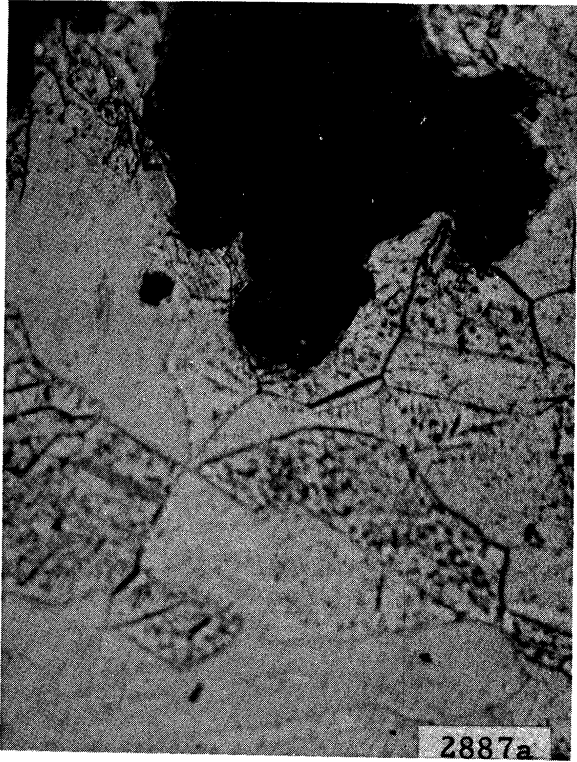
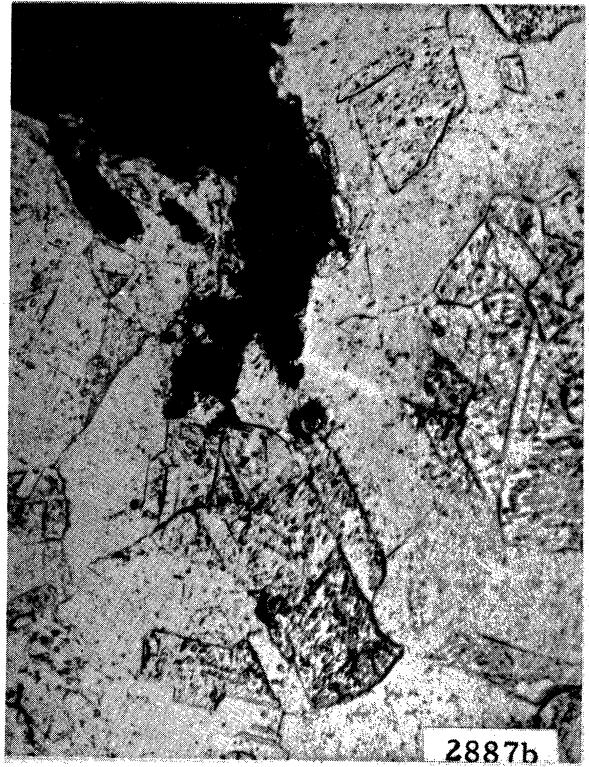
Figure 19. Photomicrographs of Cavitation Damage Area of Compression OFHC Copper Vibratory Specimens (400x)

Fig. 19 shows both the transverse (A) and the longitudinal (B) directions of a copper specimen cavitating in compression. Close examination of the photographs shows a number of microcracks at the base of the damage pits. These seem to start at the apex of the pit and continue until they intersect a grain boundary, at which point they terminate. The longitudinal picture again shows the direction of the cracks to be perpendicular to the surface. (19)
