REPORT NO. UM-HSRI-HF-73-13

INVESTIGATION OF SOME FACTORS AFFECTING THE AIM OF HEADLAMPS

Paul L. Olson
Rudolf G. Mortimer

*Highway Safety Research Institute
University of Michigan
Ann Arbor, Mich. 48105*

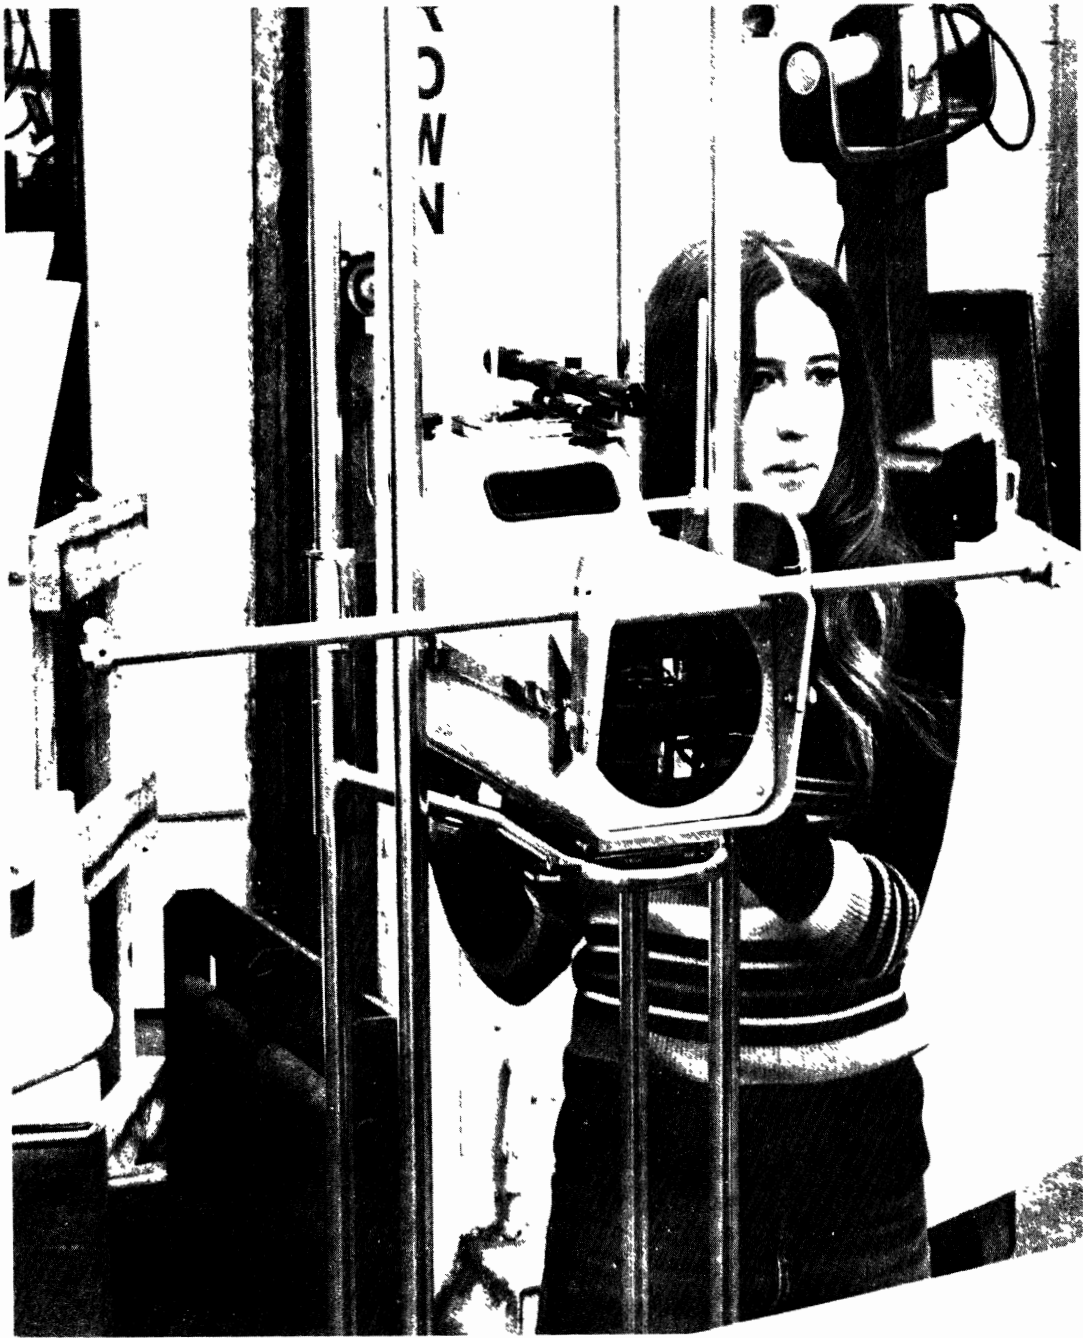
Figure 1. Visual aimer in use.

The simplest but most subjective procedure is to follow SAE specifications and aim the headlights on a screen 25 feet in front of the vehicle. Since few service outlets would have this kind of space available for aiming headlamps the visual device evaluated in this study (see Figure 1) allows the same procedure to be accomplished in a far more restricted space. Basically, the device uses a condensing lens to focus a reduced image of the beam on a miniature screen. The screen is suitably marked to indicate where the image should be positioned (Figure 2). Prior to use, the slope of the floor must be determined and the optical axis of the device aligned with the long axis of the car. The unit is located in front of each lamp with the aid of a probe, which can be raised out of the way afterwards. For high beam an alternative photometric method is provided. To use this the operator moves a mask into position until a white dot is centered on the HV point. The lamp is then adjusted until a maximum reading is obtained on the candlepower meter provided.

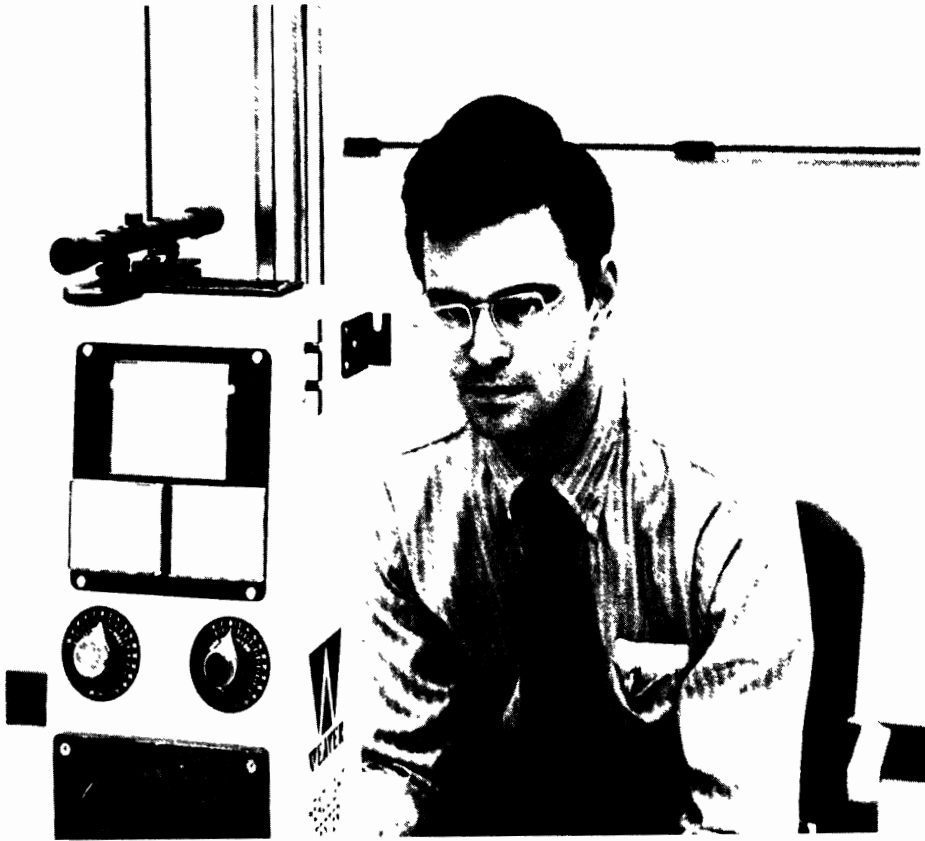
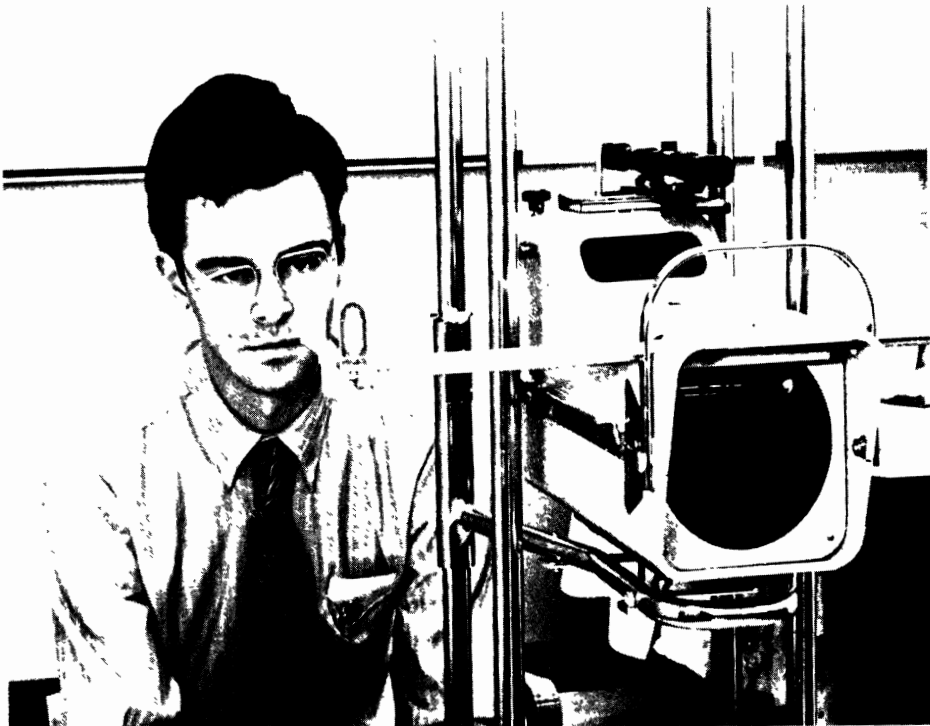
Figure 4. Sighting to align the visual and photometric aimers.

BACKGROUND. The visual and photometric aimers tested are equipped with sights which are intended to be used in aligning the unit with the long axis of the vehicle (Figure 4). In the case of the visual machine the sight consists of two wires, about six inches apart. In the case of the photometric machine, the sight consists of a yoke and blade device, the components being about 5 1/4" apart. Inspection of the unit led to a question as to the accuracy with which the sights could be used. Accordingly, the first study estimated variance associated with the use of the sighting device alone.

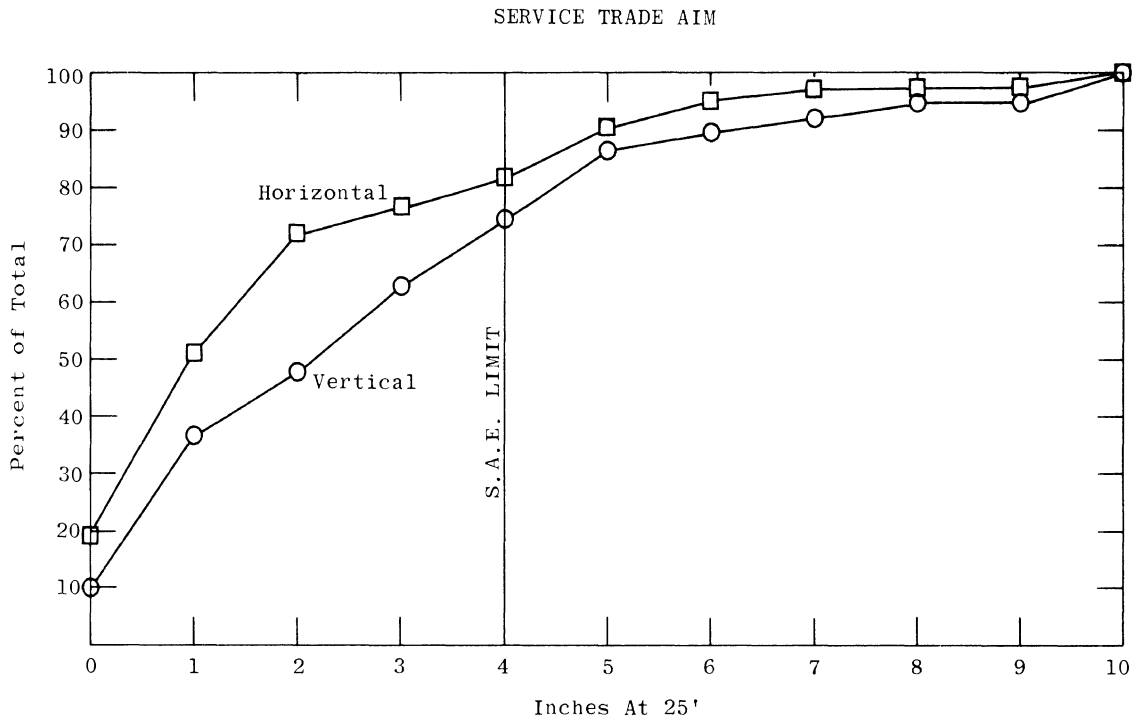
Figure 10. Cumulative frequency distributions of headlamp aims resulting from service trade survey.

RESULTS. Figure 9 shows the resulting aims of the four lamps on the test car. It is apparent that in most cases the aim was improved, though in some cases it was made worse. The data are shown in the form of a cumulative frequency distribution in Figure 10. The probability of all four lamps being within the 4" x 4" SAE recommendations was less than 0.4. (Twelve of the 32 outlets aimed all four lamps within SAE specifications.) There were 18% of the lamps misaimed more than 4" left or right, 26% misaimed more than 4" up or down, and 35% were misaimed in excess of 4" either horizontally and vertically, or both.

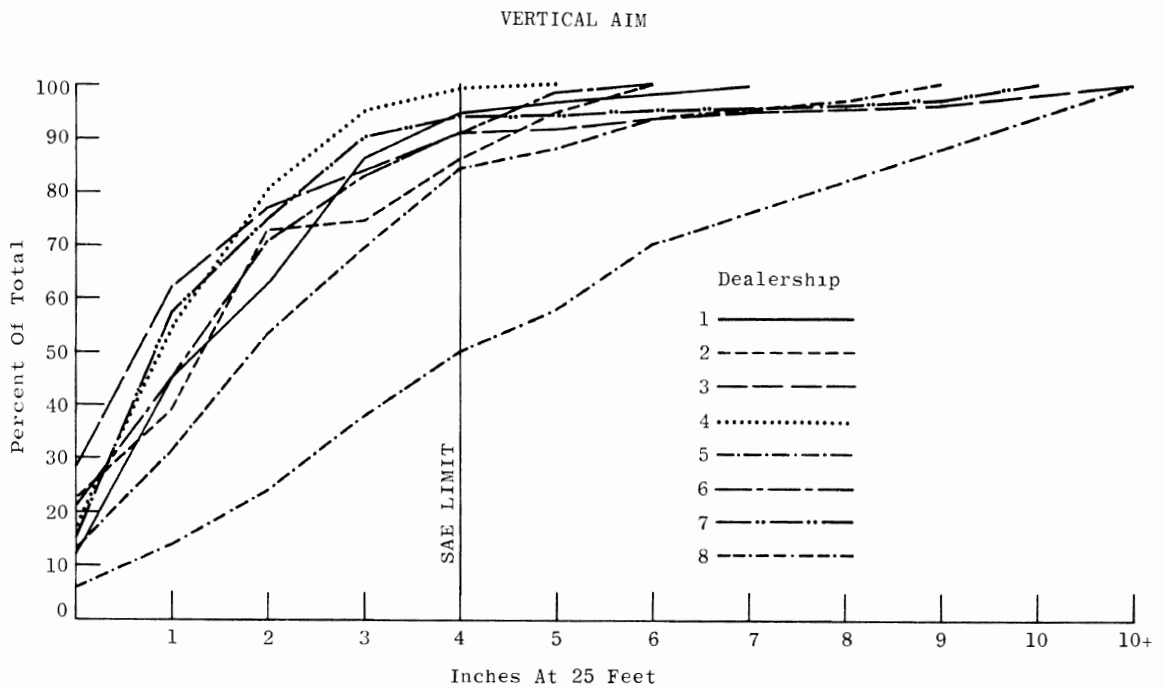
Figure 11. Results of new car aim study.

RESULTS. The results of the survey are given in the form of cumulative frequency distributions in Figure 11. These data are for individual lamps. Horizontal aim was somewhat better than vertical with at least 90% of the lamps at any dealership being within ± 4 inches at 25 feet, as recommended by SAE. With the exception of one dealership, at least 84% of lamps were in specification vertically as well.

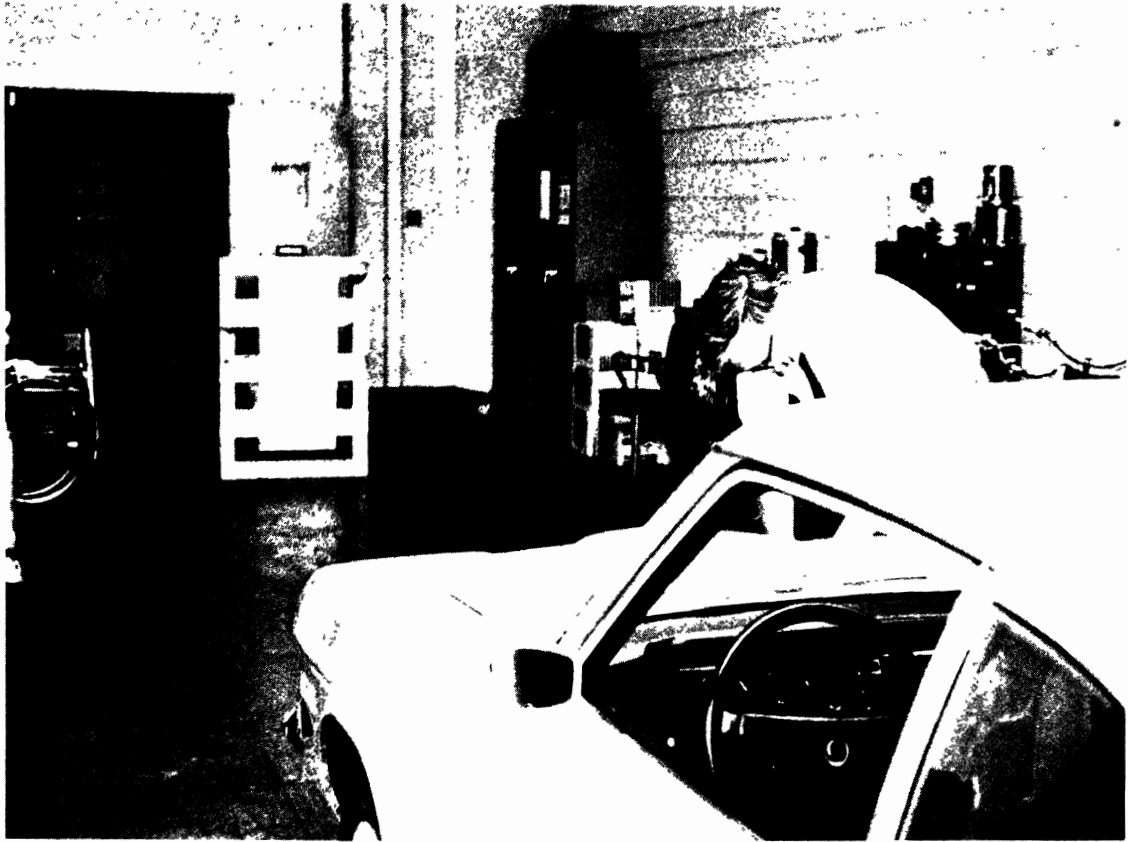
Figure 13. Set-up used in vehicle loading study.

on the roads today. Each car was moved to a specific position on a ramp facing into a darkened room. A spot aimer was used (Figure 12) and focused on a screen 25 feet from the lamp (Figure 13). A first measurement was taken with a full gas tank and 150 lbs in the drivers' seat. All other measures were referenced to this one. Two readings had to be taken each time; the height of the spot on the screen and the height of the aimer.
