Development of Measurement Techniques for Studying Propeller Erosion Damage in Severe Wake Fields

Naval Surface Warfare Center, Carderock Division(NSWCCD)
9500 MacArthur Boulevard
West Bethesda, MD 20817

ABSTRACT

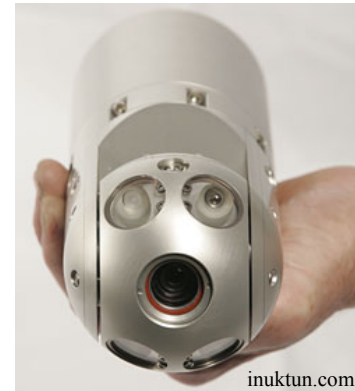
Figure 5: Submersible Camera

The blade sheet cavitation was viewed with a submersible Inuktun Spectrum 90 pipe inspection camera (Figure 5) mounted inside the wake generation foil immediately upstream of the propeller. Plastic windows contoured to the foil trailing edge allowed a direct view of the propeller blade as it passed through the foil's wake. This installation is shown in Figure 6. This camera system had remote pan and tilt capability, allowing the camera view to sweep radially and tangentially relative to the propeller. Images were acquired at 30 frames per second with a pixel resolution of 320 x 240 and recorded on a mini-DV tape recorder. Although this camera system has an internal incandescent light source, a strobe light system was set up to trigger off of a one-pulse per revolution signal, syncing the strobe flashes with the propeller rotation. Some frames were lit by the strobe and some were dark using this lighting scheme with the camera at 30 frames per second. The dark frames were digitally removed after acquisition to obtain continuous frame sequences with the propeller motion "frozen" by the strobe light. This camera view showed the overall extent of sheet cavitation as well as its variability from one blade passage to the next.

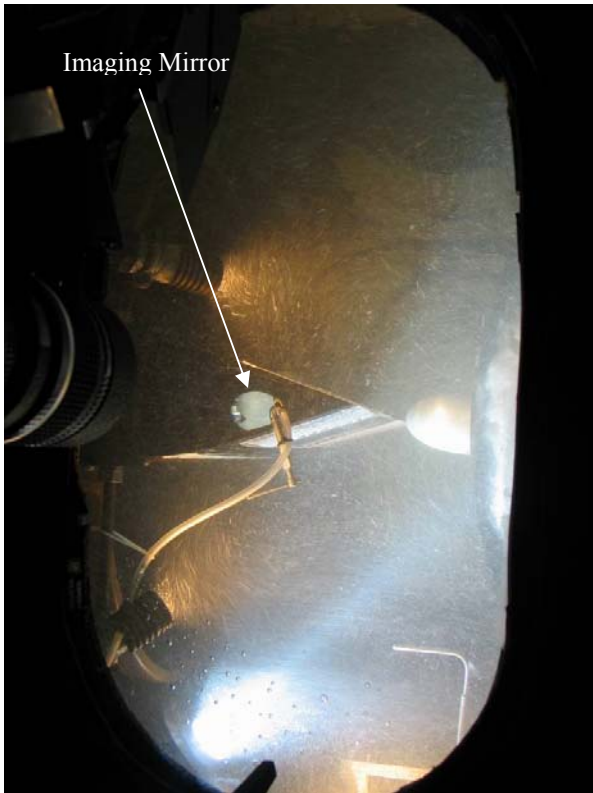
Figure 7: High speed imaging setup

The HS system camera lens was focused through a hole in the wake-generating foil onto a small mirror mounted to the head of the Inuktun submersible camera. Using the pan and tilt control of that system, the mirror could be adjusted to provide a direct view of the propeller blade with the same aspect as the submersible camera (see Figure 7). This provided a direct view of the collapse region of the blade's sheet cavity. The HS imaging system was a Photron camera system with frame rates up to 6000 fps and pixel resolutions up to 1K x 1K. This high frame rate showed the development of a single cavitation event and details of the collapse of cavitation bubbles on the blade surface. The lighting for the HS system was provided by five submersible flood lights and two externally mounted photography flood lights. The lighting requirements were even more demanding because the lens was zoomed to spread the image reflected from the small mirror over the entire image sensor.

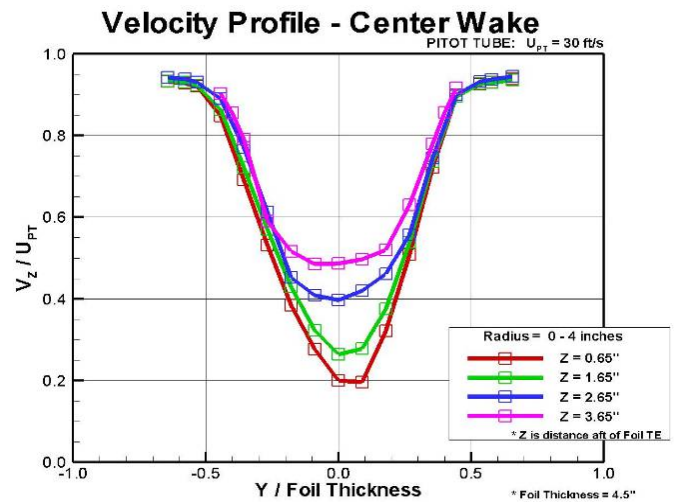
Figure 8: LDV Wake Survey - Center Wake Velocity Profile

These surveys were taken with a fairwater and dummy hub in place of the propeller. Vertical profiles (Y-positive up, Z-positive downstream) of the wake for all 4 axial locations at a tunnel velocity of 30 ft/sec (9 m/sec) are shown for the center of the wake in Figure 8 and for the propeller tip region of the wake in Figure 9. A full plane survey of the measured velocities 0.65 inches (16.5 mm) downstream of the foil is shown in Figure 10 as a contour plot. An outline of the propeller blade has been added to show where the wake falls on the blade.

Figure 8 shows a wake deficit of as much as 80% and a thickness close to the strut thickness (4.5 inches, 114.3 mm) at the prop center. These are good conditions for mid-blade cavitation collapse. However, Figure 9 and Figure 10 also show a large, wide wake deficit ($0.1 V_z/U_{pt}$) out at the tip region of the 16 inch propeller. This large deficit is essentially a wall effect caused by the junction of the 24 inch VPWT contraction nozzle with the wake generation strut and the sudden entry of the flow into the open test section.

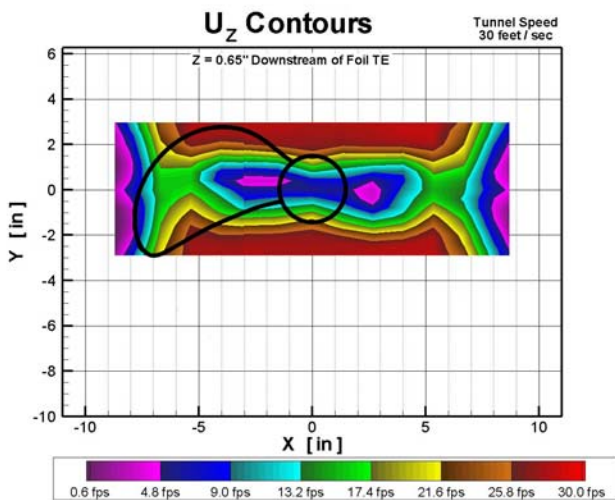
Figure 10: LDV Wake Survey - Velocity Field 0.65 inches downstream of the strut

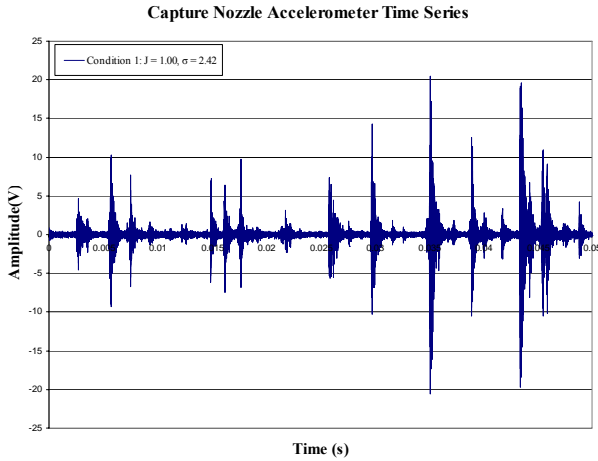
Figure 15: Accelerometer Time-Series

The 0.2 second samples acquired from the 3 accelerometers mounted in the 24 inch VPWT were recorded at the 4 operating conditions indicated in Table 1. The 500 kHz time series samples of 0.2 seconds long were digitally high-pass filtered at 50 kHz to remove low frequency content. Figure 15 shows a sample filtered time-series of data acquired from the accelerometer mounted on 24 inch VPWT capture nozzle. The bursts in the accelerometer time series are associated with cavitation collapse events.

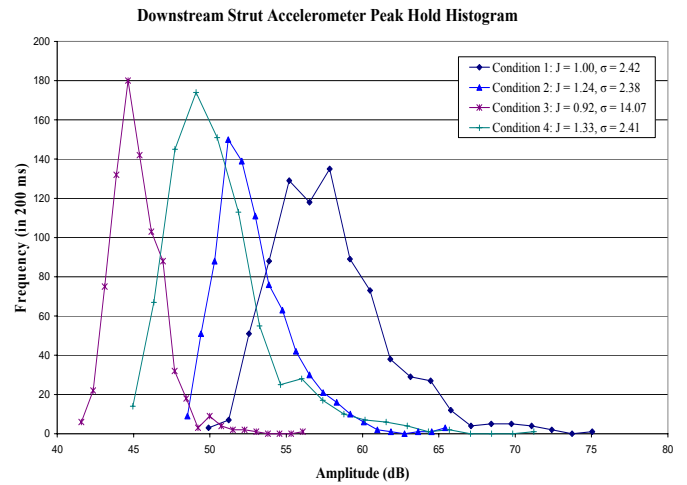
Figure 16: Accelerometer Peak-Hold Histogram

The different cavitation conditions can be clearly distinguished by the different positions and shapes of the peaks. Condition 1 had the highest intensity cavitation and consisted of tip vortex and suction side leading edge cavitation forms. Conditions 2 and 4 were similar with both tip vortex cavitation and pressure side leading edge cavitation. However, condition 2 had a more pronounced tip vortex, appearing as a higher amplitude peak, while condition 4 had more pressure side cavitation. Condition 3 was a low intensity condition with only tip vortex cavitation present.

The peak-hold data were plotted as a histogram showing the frequency of occurrence of amplitudes over the 0.2 second time series. By analyzing the peak in this histogram, threshold levels for different cavitation conditions can be compared. Peak hold histograms for the 4 accelerometer cavitation conditions are shown in Figure 16 for the downstream strut accelerometer.

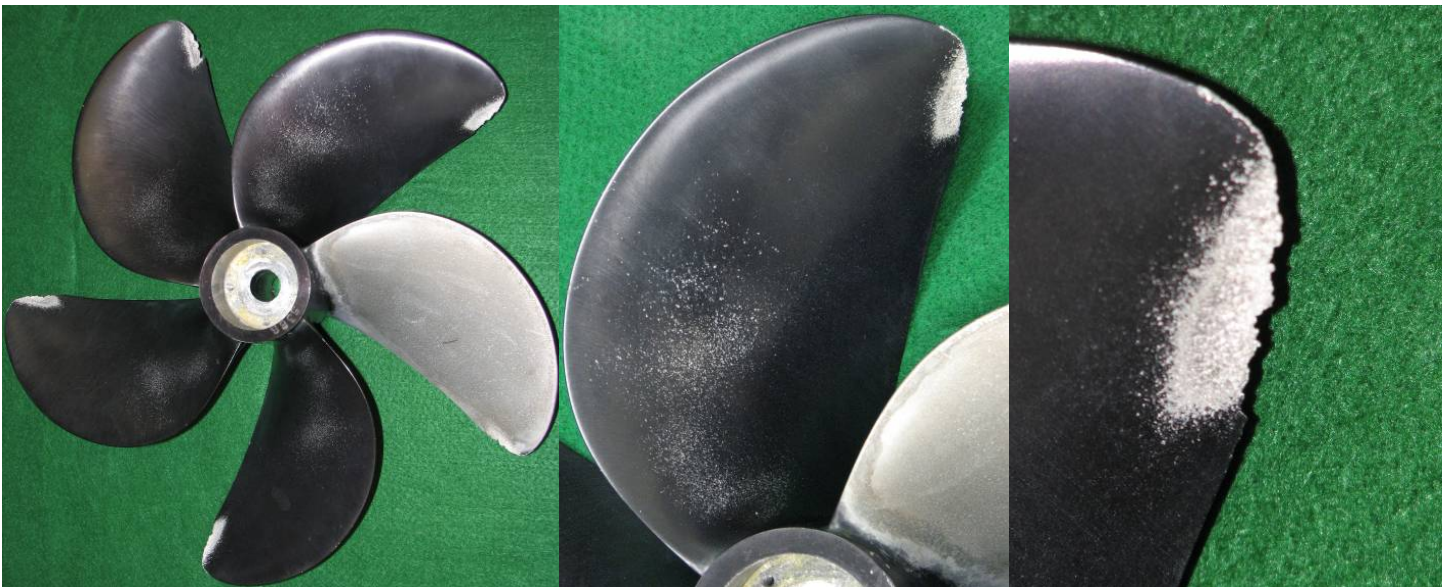
Figure 17: Cavitation Erosion Damage

is attributed to leading edge suction side cavitation

The brush-on stencil ink was also a good indicator of the location where cavitation erosion would eventually occur. When the propeller was run at this same condition for a longer time, pits of material were removed (see Figure 17) that matched the stencil ink removal pattern. As has been shown in previous studies [7], stencil ink is a good indicator of existence and location of future cavitation erosion damage.

The resulting damage of the 16 inch propeller from extensive operation at extreme cavitation conditions is shown in Figure 17. The most damage occurred at the tip. However, removal of the propeller anodization matching the stencil ink removal pattern on the mid-blade area is seen in Figure 11. This
