CASE REPORTS

Electromagnetic Interference in an Implantable Loop Recorder Caused by a Portable Digital Media Player

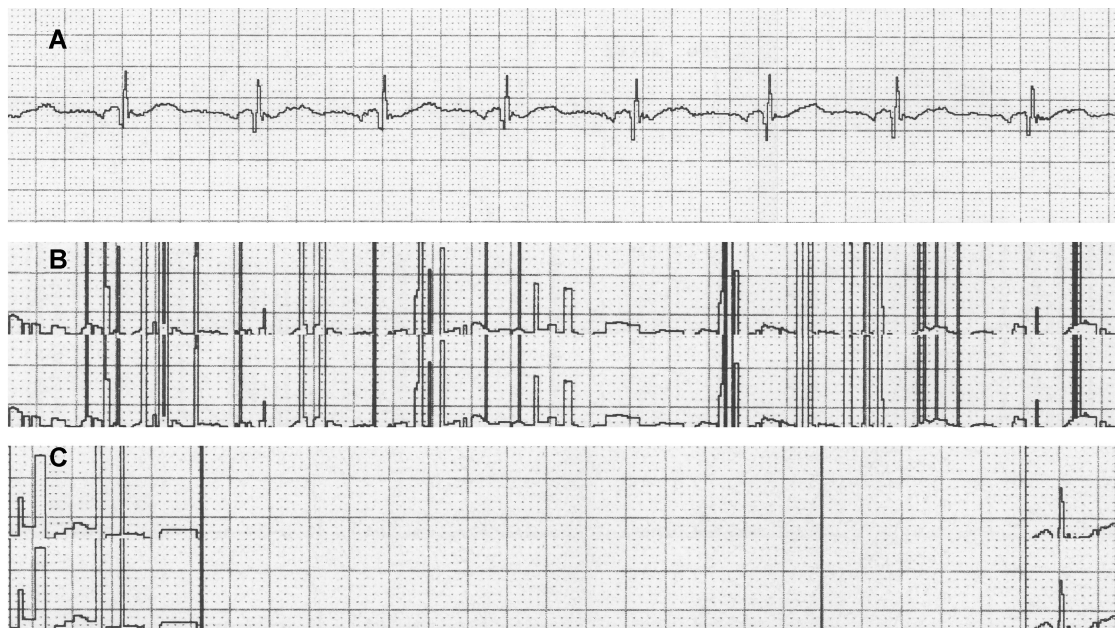
positioned on the device for interrogation, interference was noticed on the telemetry ECG channel, while the surface ECG on a bedside monitor remained unchanged. The artifact on the monitor screen had an abrupt onset and termination, synchronous with the turning on and off of the iPod and was highly reproducible. The native QRS complexes in the telemetry ECG were either missing or distorted during the interference (Fig. 1). On interrogation of the ILR after the test, there were no patient-activated events recorded.

Figure 1. Real time telemetry ECG recordings of implantable loop recorder are shown. They were obtained using the programmer with the wand over the ILR. Panel A shows baseline recording and panels B and C, during iPod exposure. Panel A shows normal rhythm without any noise, Panel B shows high-frequency spikes, and Panel C shows blanking.

Telemetry interference similar to Figure 1 was duplicated in this patient. When the iPod was turned on and left next to the ILR and the activator switch pressed, the activator light consistently blinked yellow. On two out of 10 attempts, the light blinked green, indicating successful capture of ECG. However, interrogation of the ILR afterward did not show any captured events. Failure to capture events with the light turning green was reconfirmed one more time.

The activator communicates with the ILR at a frequency of 100–250 kHz. The iPod also emits electromagnetic radiation in this range with field strength of approximately 1 mGauss. This may explain the telemetry interference as well as the inability of the activator to communicate with the ILR. While telemetry interference is not of any clinical significance, failure of the activator to capture an event or false impression to the patient that an event has been captured may reduce the effectiveness of this useful device.
